# Heritage Square South

## Level 1 Reserve Study

**Report Period - 1/1/2020 to 12/31/2020**

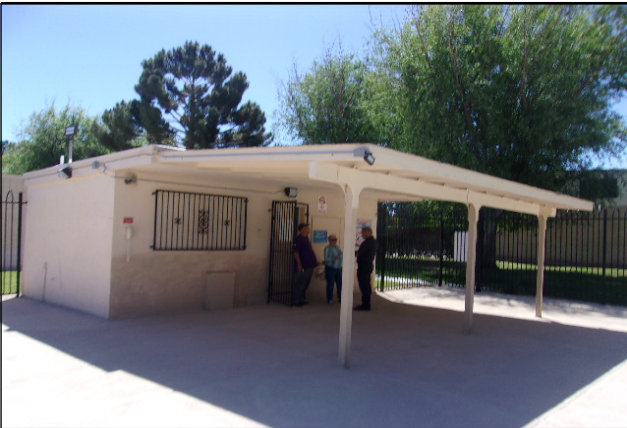
Roof is in good condition. No problems noted at the time of inspection. This type of roof has a typical useful life of approximately 18 to 20 years. Remaining life based on current age.

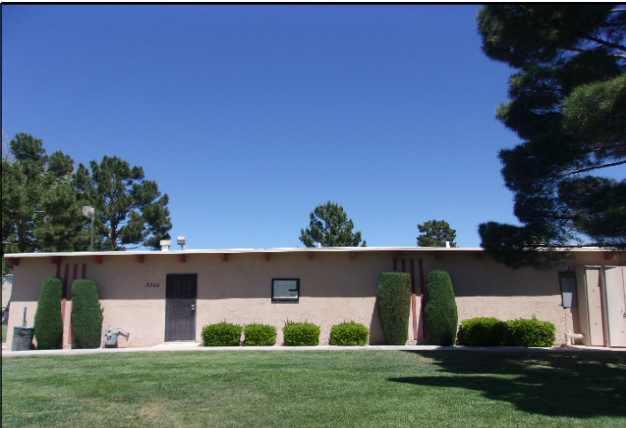
No problems noted at the time of inspection. No evidence of significant ponding or soft spots. This type of roof has a typical useful life of approximately 20 to 25 years. Remaining life based on current condition.

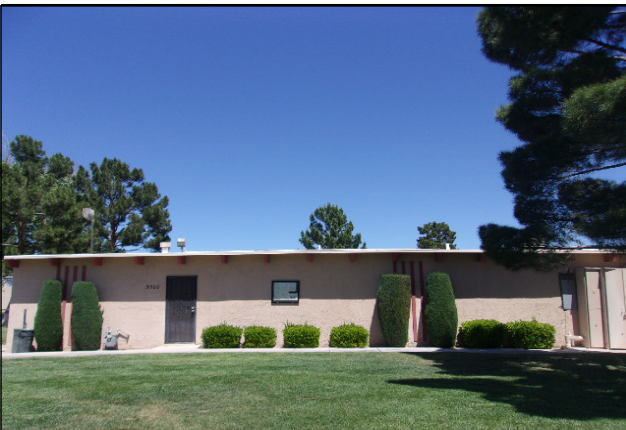
Foam roofs require periodic sealing to prevent UV damage to roof material. We recommend performing this project in the near future.

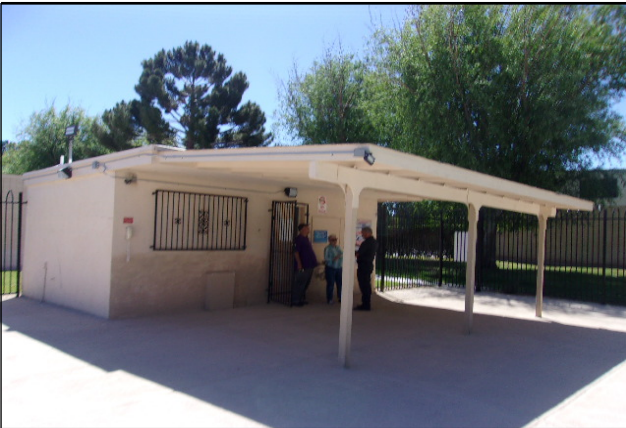
Foam roofs require periodic sealing to prevent UV damage to roof material. We recommend performing this project in the near future.

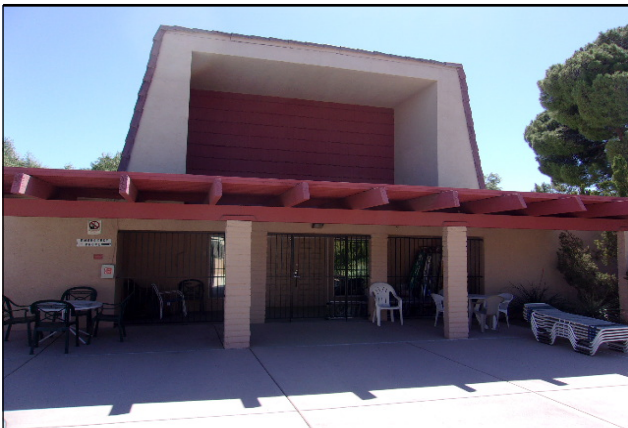
Inspect roofs regularly and make repairs as necessary as an operating expense to ensure full life. We recommend to replace the flat portions of the building roofs approximately every 15 years.

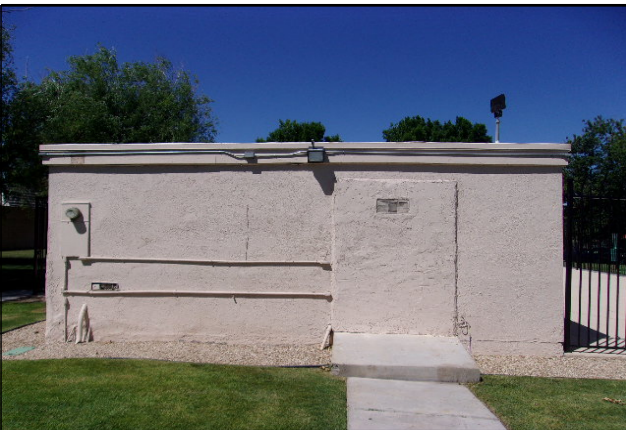
Roof is in good to fair condition. No problems noted at the time of inspection. This type of roof has a typical useful life of approximately 18 years. Remaining life based on current condition.

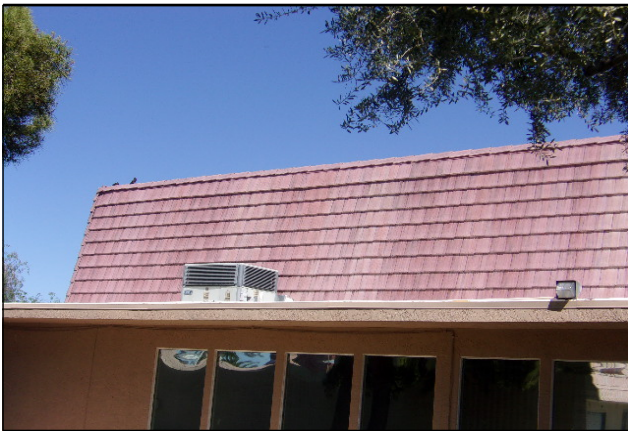
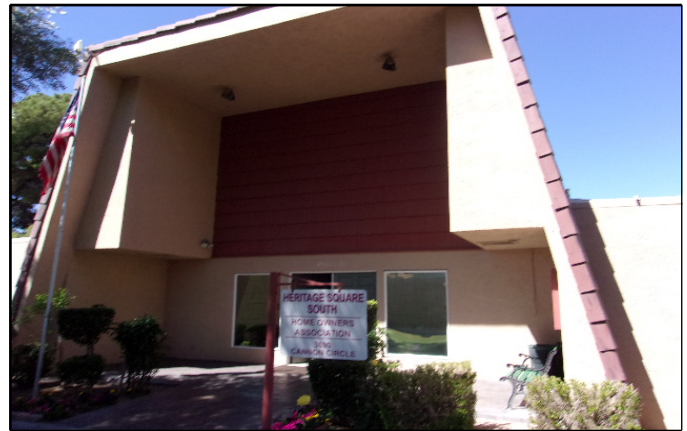
No problems noted or reported. Tile roofs have a typical life expectancy of approximately 25 to 30 years before underlayment deterioration causes significant leaks. Inspect roofs regularly and make repairs as necessary as an operating expense to ensure a full useful life.

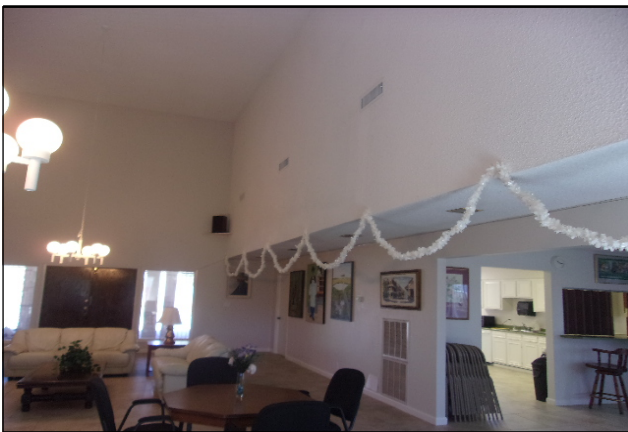
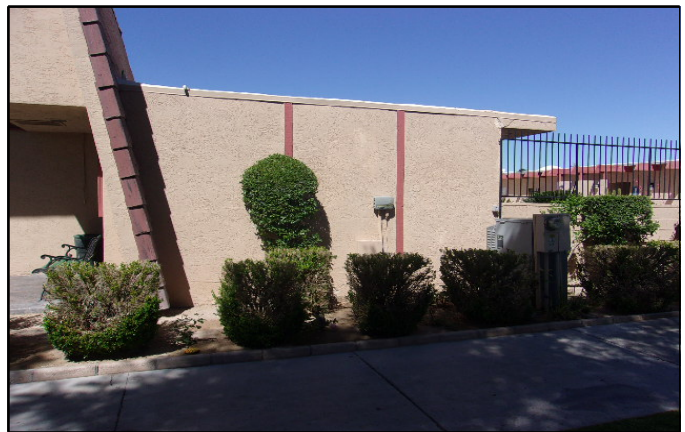
Expect to repaint the clubhouse approximately every 10 to 12 years. Remaining life based on current condition.

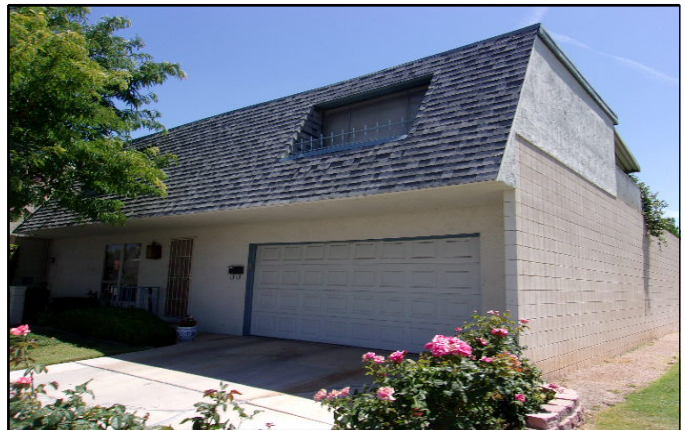
Painted exterior surfaces are painted in sections annually. We recommend repaint each unit approximately every 10 years.

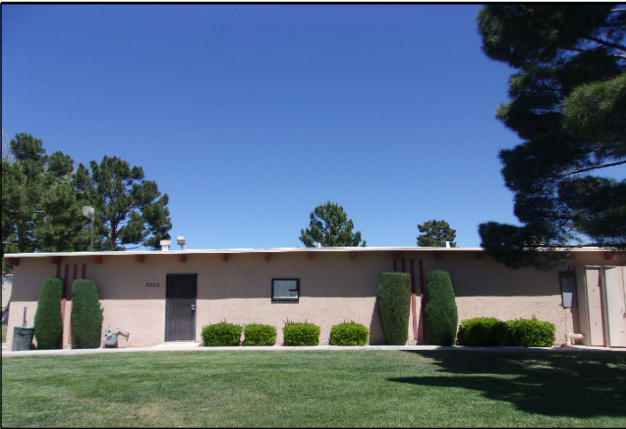
Building exterior painted surfaces are good condition. No staining and discoloration noted. Expect to repaint stucco surfaces approximately every 10 to 12 years to maintain appearance and protect stucco. Remaining life based on current condition.

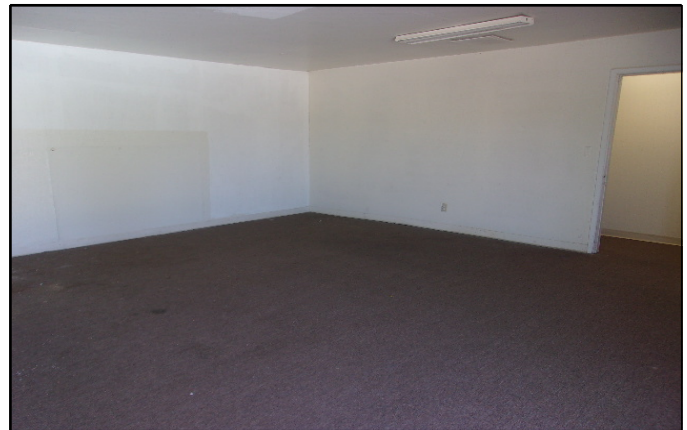
Interior painted surfaces are generally in poor condition. We are funding to repainted these surfaces approximately every 8 to 12 years for proper appearance and function.

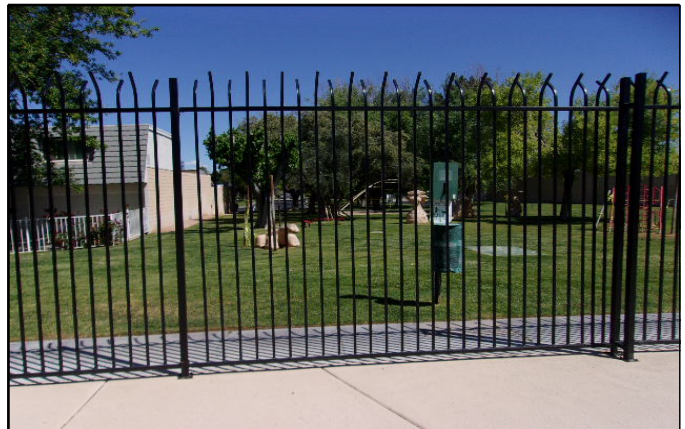
Painted wrought iron surfaces are in good condition, no rusting or paint loss noted. Repaint this component approximately every 5 years to maintain appearance and protect metal surfaces. Remaining life based on current condition.

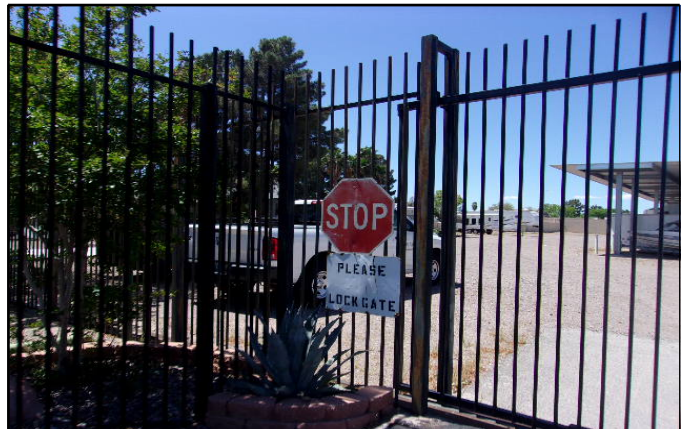
Painted wrought iron surfaces are in good condition, no rusting or paint loss noted. Repaint this component approximately every 5 years to maintain appearance and protect metal surfaces. Remaining life based on current condition.

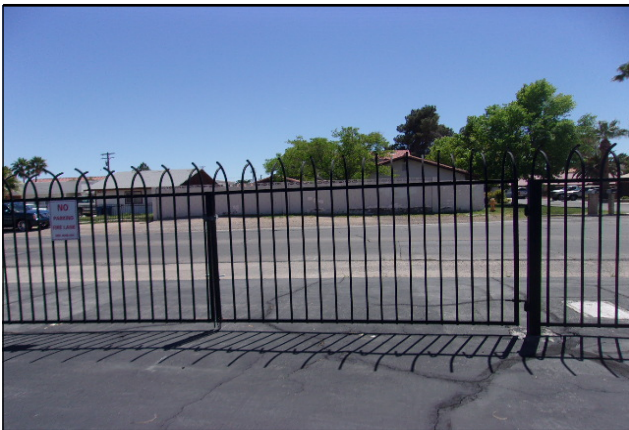
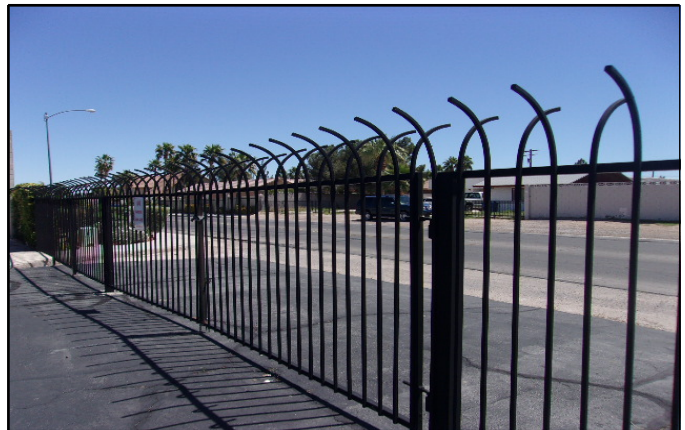
No appearance concerns or rust intrusion noted. Expect to repaint these surfaces approximately every 3 to 5 years. Remaining life based on current condition.

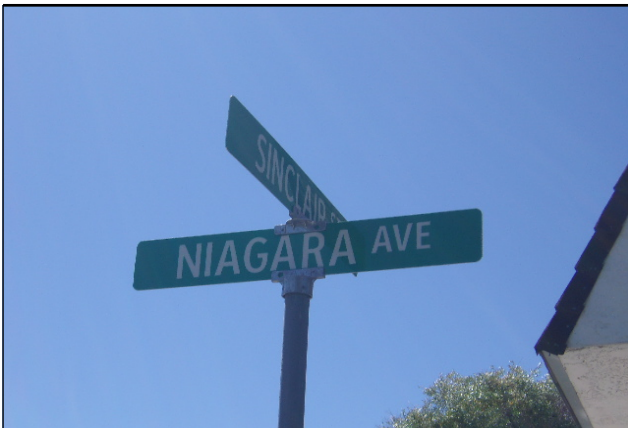
Client reports all street signs were replaced 2014. Expect a full useful life of 20 years from this component. Remaining life based on current age.

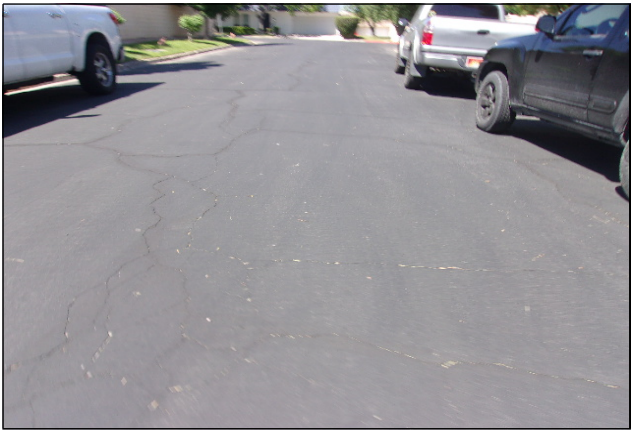
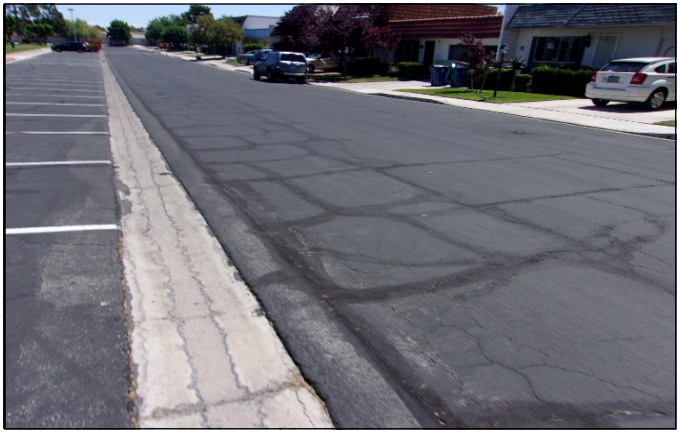
Asphalt surface is generally in good to fair condition. Noted moderate cracking in areas. Client reports that these surfaces were overlaid in approximately 2000. Asphalt overlay generally has a useful life of 25 - 30 years. Maintain seal coat schedule to ensure full useful life. Remaining life based on current age and condition.

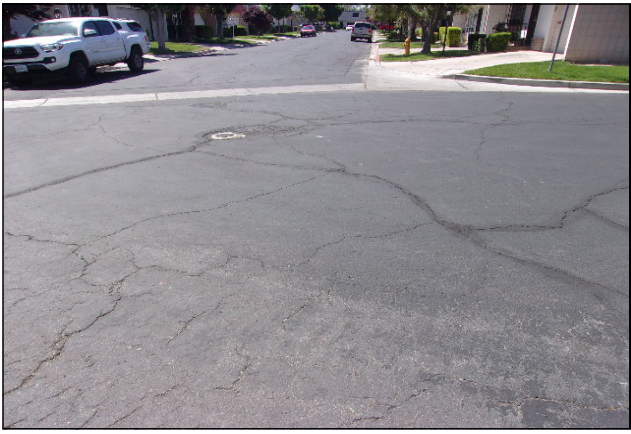
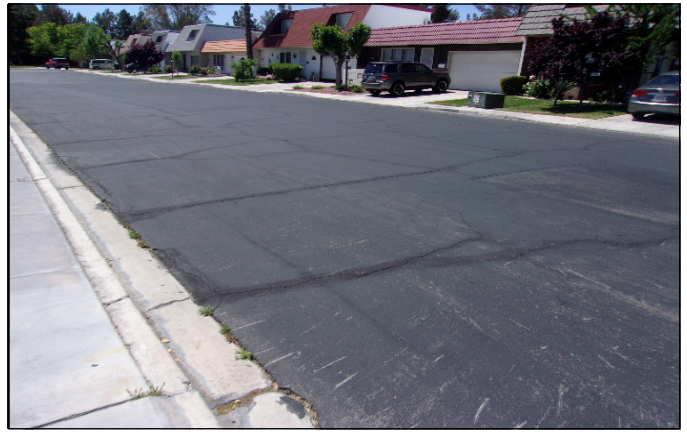
Asphalt seal coat is in good condition. No significant surface loss noted. Client reports that the streets were sealed in 2013. Seal asphalt surfaces regularly to prevent premature overlay (see Comp# 401 Asphalt - Major Rehab). Remaining life based on current age and condition.

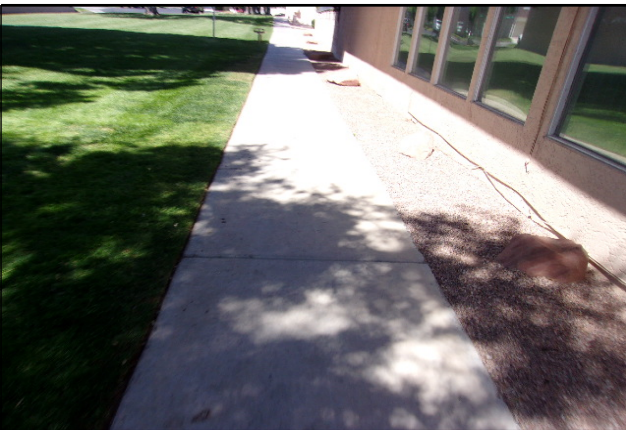
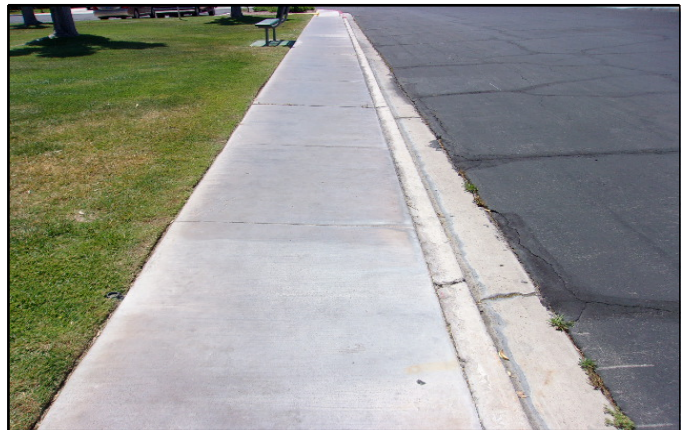
No expectation to completely replace the concrete surfaces. We recommend making local repairs as necessary as an operating expense and funding to make more significant repairs approximately every 10 years.

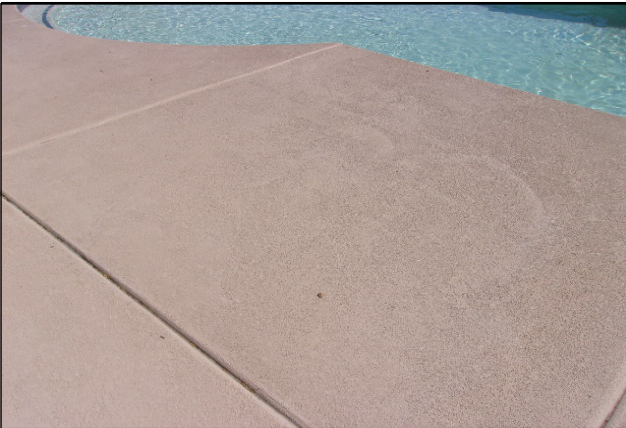
Decks are in good condition. Seal these decks approximately every 5 years to protect deck surface and prevent premature deck resurface (see Comp# 604 Pool Deck - Resurface).

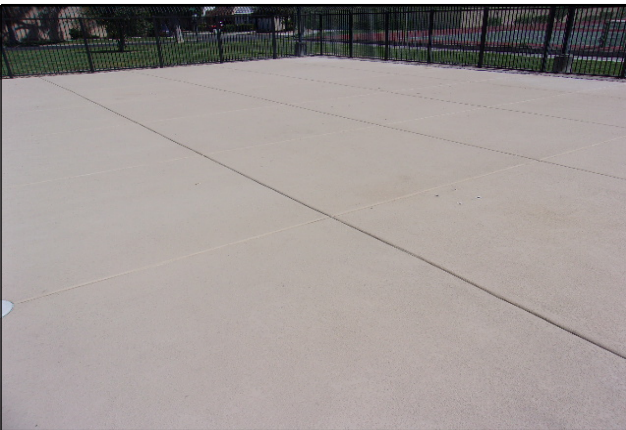
Pool decks are in good condition. Seal these decks approximately every 5 years to protect deck surface and prevent premature deck resurface (see Comp# 604 Pool Deck - Resurface).

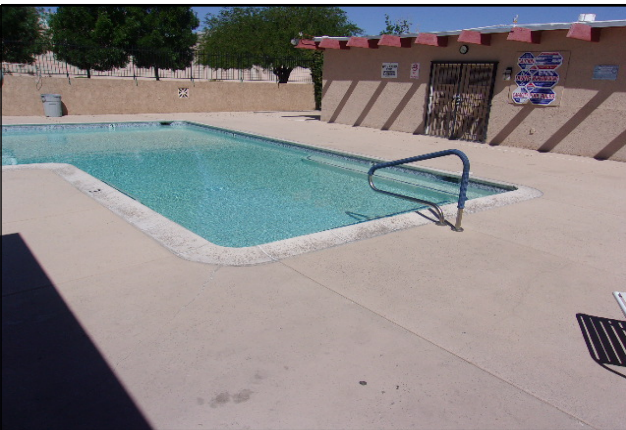
Pool deck is generally in fair condition. No significant surface loss or unusual wear noted. Expect to reseal this decking approximately every 3 to 5 years depending on use and wear. Remaining life based on current condition.

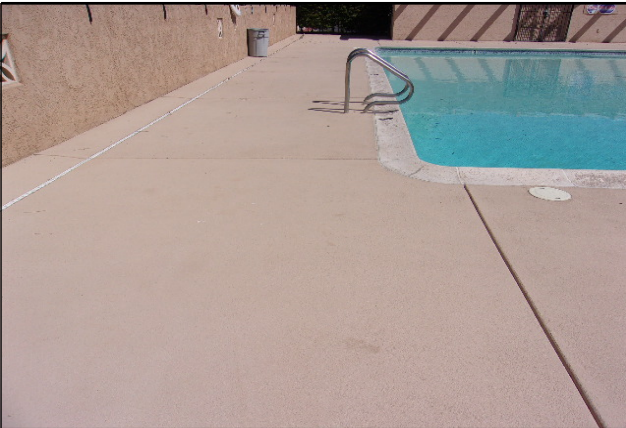
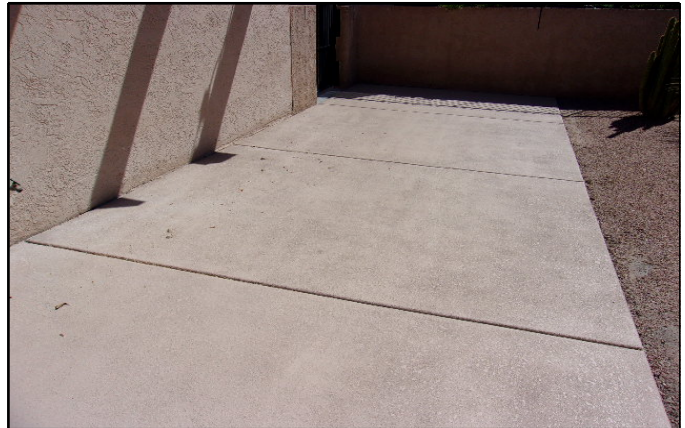
Deck is in good condition. Expect to seal this component approximately every 5 years (see Comp# 603 Pool Deck - Reseal) and to completely resurface approximately every 20 years.

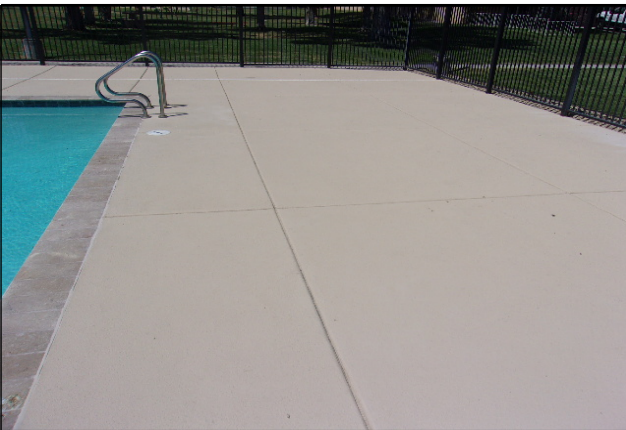
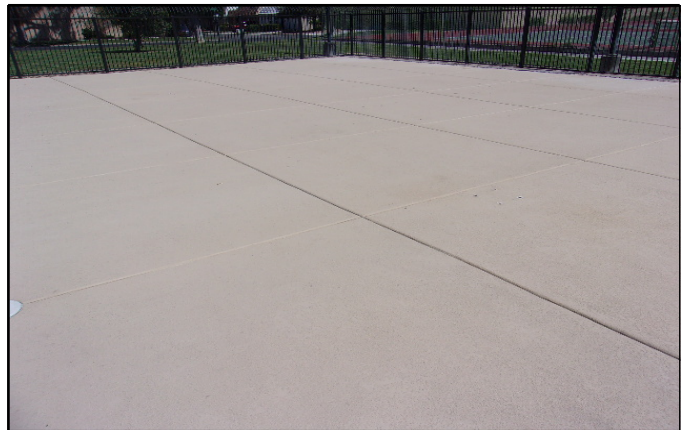
Pool decking is generally in good condition. Expect to seal this component approximately every 5 years (see Comp# 603 Pool Deck - Reseal) and to completely resurface approximately every 20 years.

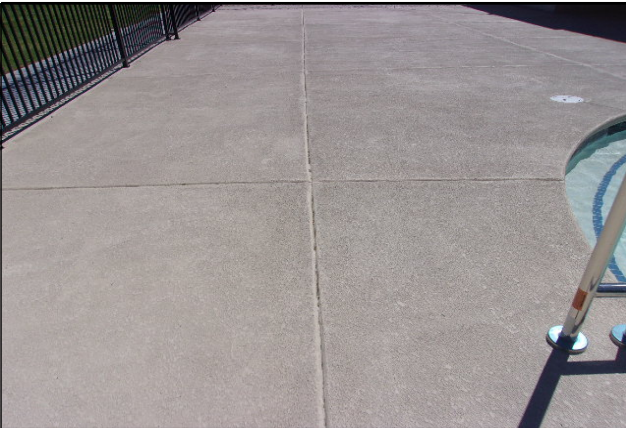
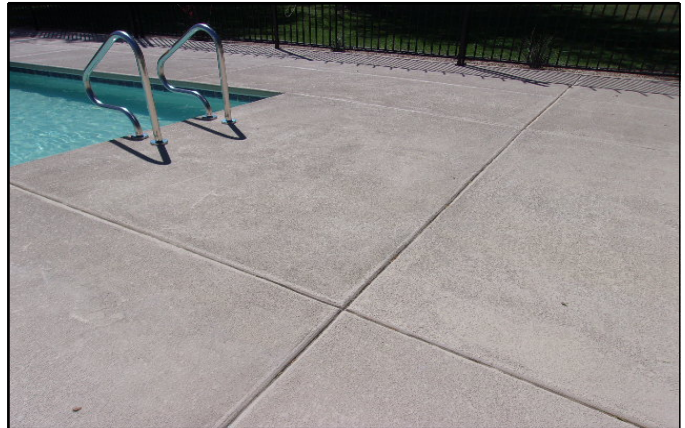
Deck is in good condition. Expect to seal this component approximately every 5 years (see Comp# 603 Pool Deck - Reseal) and to completely resurface approximately every 20 years.

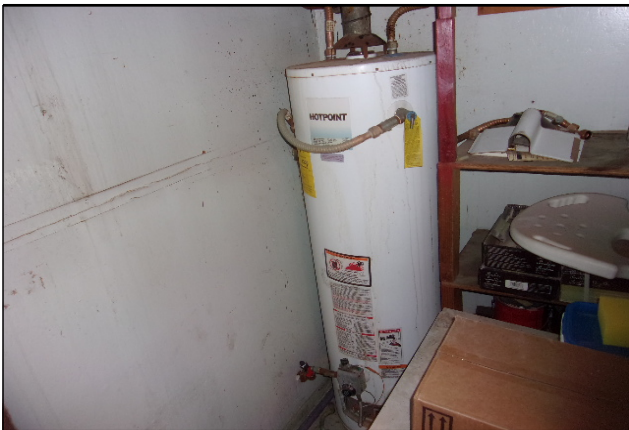
No problems noted or reported at time of our site visit. We recommend funding to generally replace this water heater approximately every 10 to 12 years. Remaining life based on current condition.

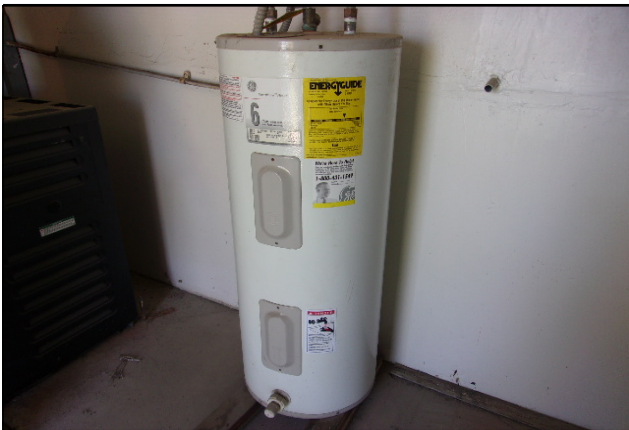
Water heater is generally older and near the end of its Useful Life. Expect a typical useful life of approximately 12 years from this component. Remaining life based on current condition.

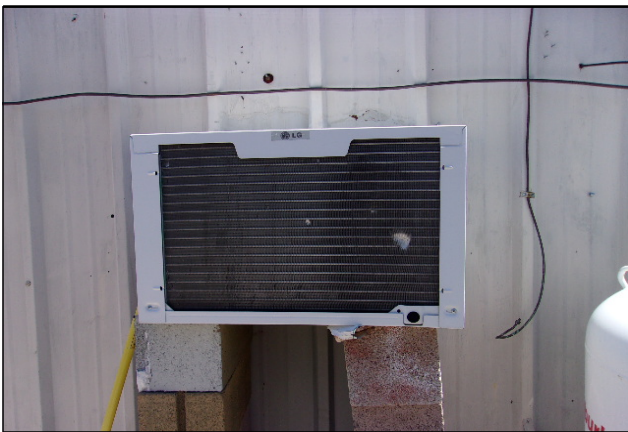
Client has informed this component has been removed from service. No reserve funding necessary.

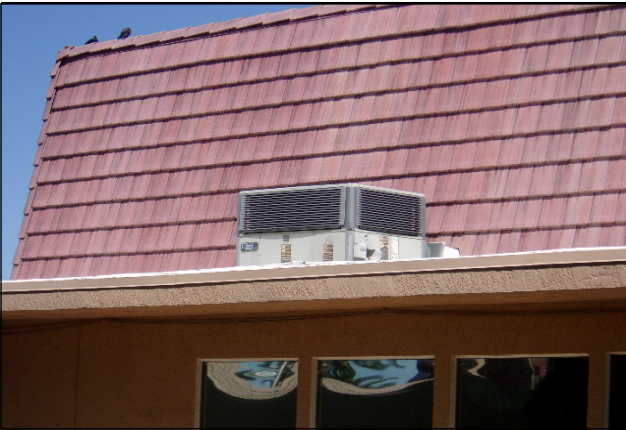
No problems reported, unit appears to be in good condition. We recommend funding to replace this unit approximately every 15 to 18 years.

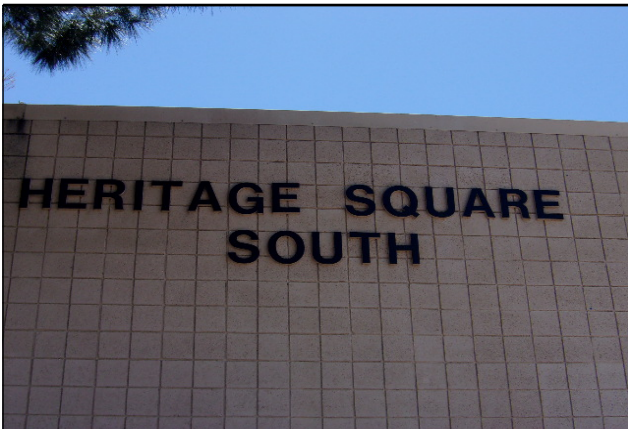
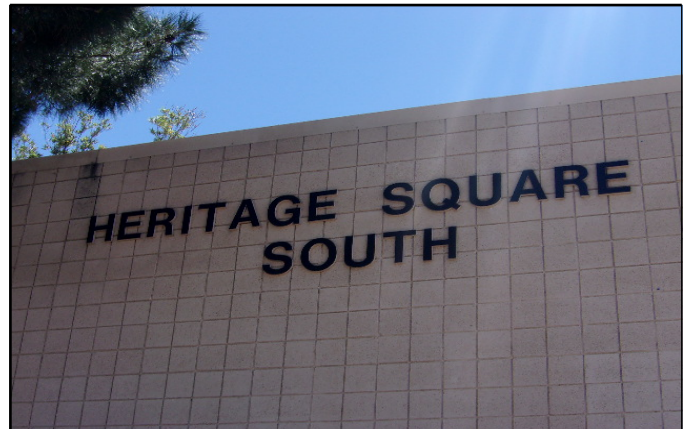
Letters are in good condition. Although these letters may reach an extended life we recommend funding to replace them approximately every 20 to 25 years to ensure appearance. Repaint letters as necessary as an operating expense.

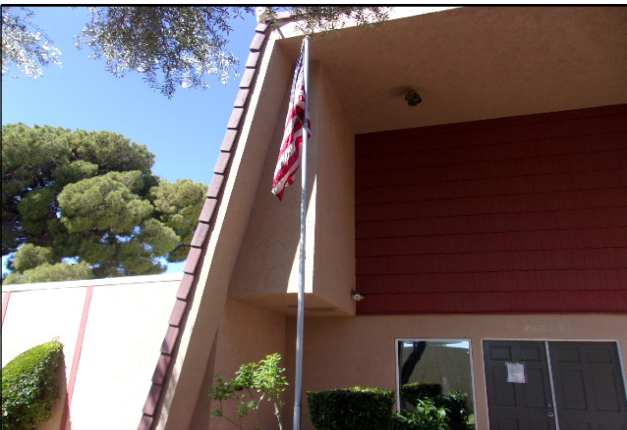
Although flag poles should have an extended life we recommend funding to replace this component approximately every 25 to 30 years. Flagpole

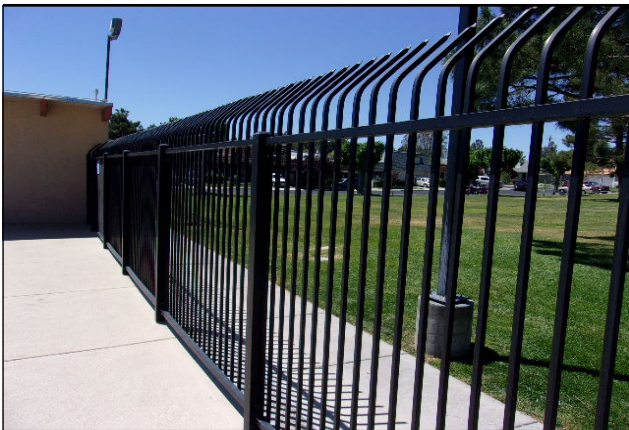
Noted advanced surface rusting but no structural problems observed. With regular maintenance and repairs expect a useful life of approximately 20 to 25 years from this fencing. Remaining life based on current condition.

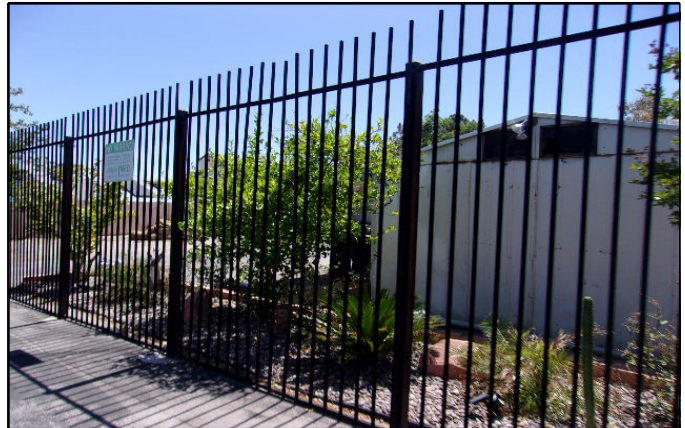
No problems noted or reported. With regular painting and maintenance expect a useful life of approximately 20 to 25 years from this fencing. Remaining life based on current condition.

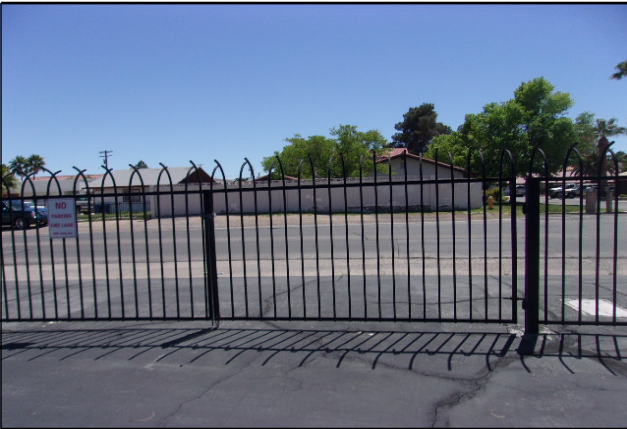
Fencing is in good condition. No significant rusting or structural problems noted at the time of site visit. With regular painting and maintenance, expect a useful life of 20 to 25 years from this component. Remaining life based on current condition.

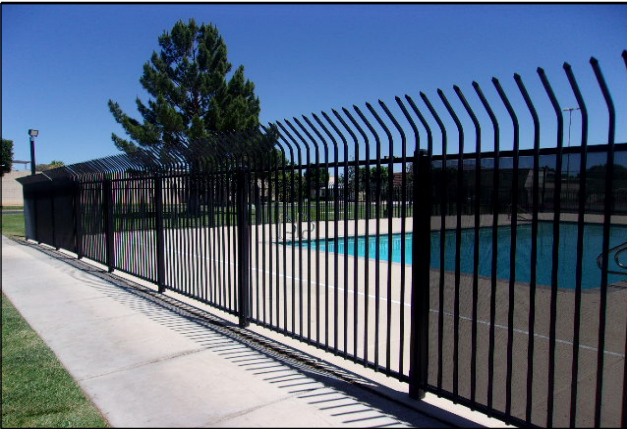
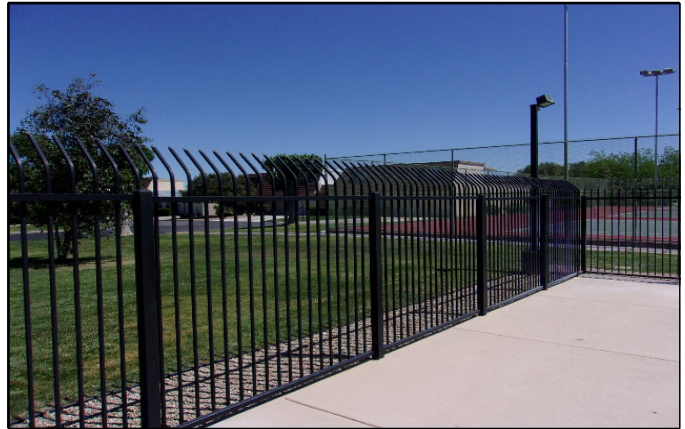
Fencing is in good condition. No significant rusting or structural problems noted at the time of site visit. With regular painting and maintenance, expect a useful life of 20 to 25 years from this component. Remaining life based on current condition.

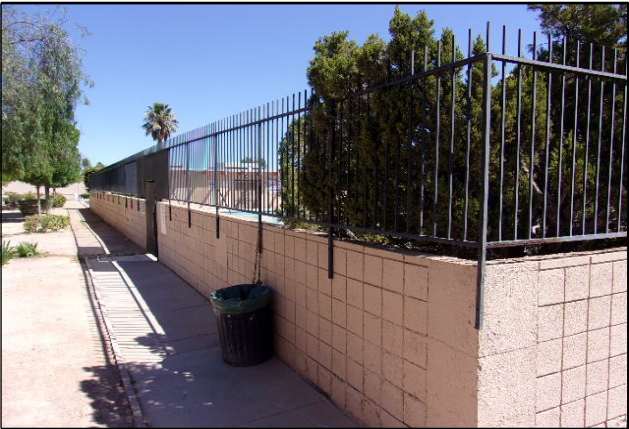
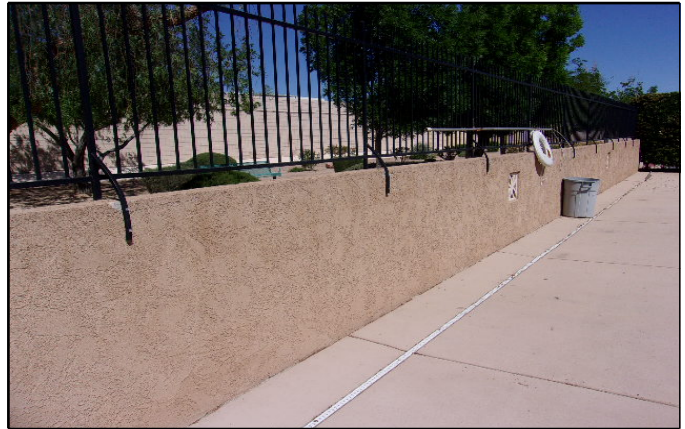
Fencing is in good condition. No significant rusting or structural problems noted at the time of site visit. With regular painting and maintenance, expect a useful life of 20 to 25 years from this component. Remaining life based on average condition.

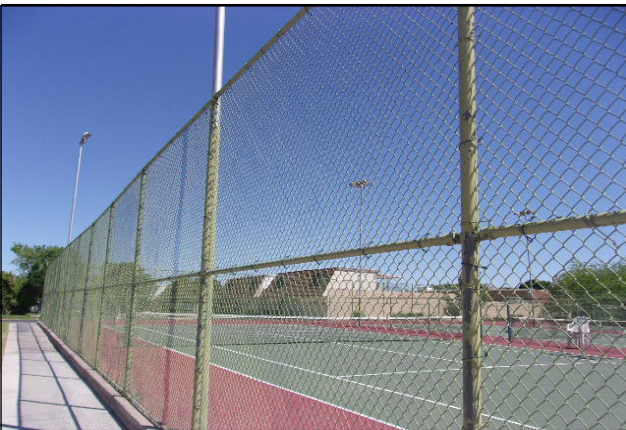
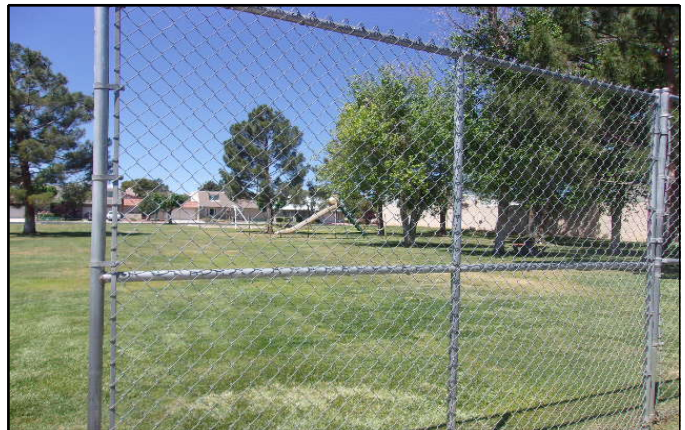
Although this fencing may reach an extended life we recommend funding to replace it approximately every 25 to 30 years. Remaining life based on current condition.

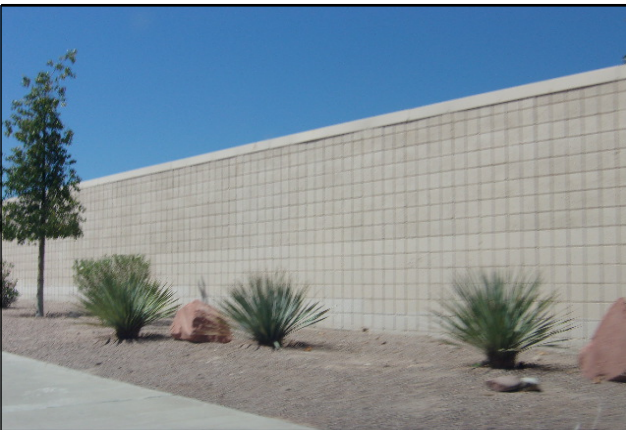
No expectation to completely replace walls. Expect to make local repairs as necessary as an operating expense and funding for an allowance to make more significant repairs approximately every 5 years.

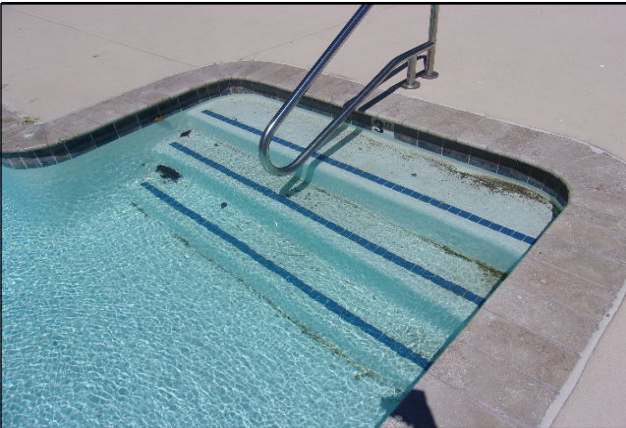
Pool surface is in poor condition and the pool is sinking. We recommend funding to resurface the pool at the same time as the repairs.

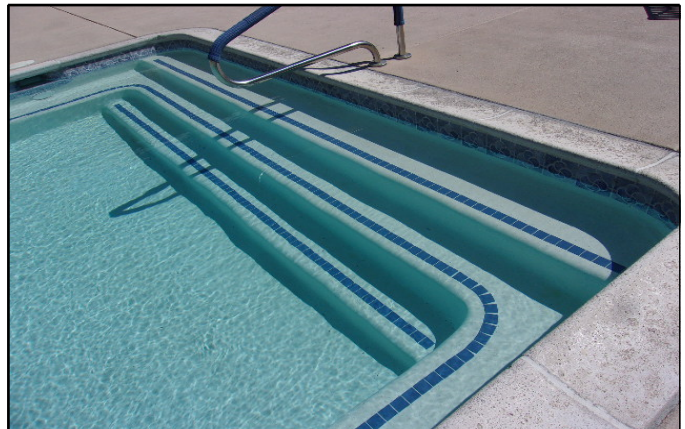
Pool surface is in fair condition. Minor discoloration noted but no surface loss observed. Perform regular, professional maintenance and keep debris from collecting at the bottom to ensure full life from this component. Remaining life based on current condition.

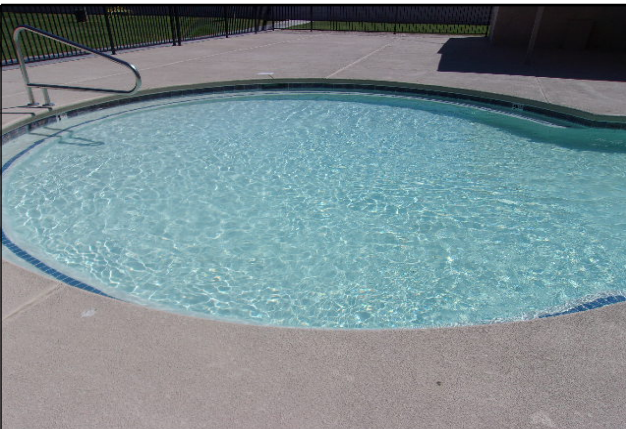
Comp # 1103 Wading Pool - Resurface

Wading pool is in good to fair condition with no discoloration or significant surface loss noted. This type of shallow wading pool typically requires resurfacing more frequently than a full sized pool because the entire pool floor is walked on. Reserve to resurface this wading pool on a 6 year schedule.

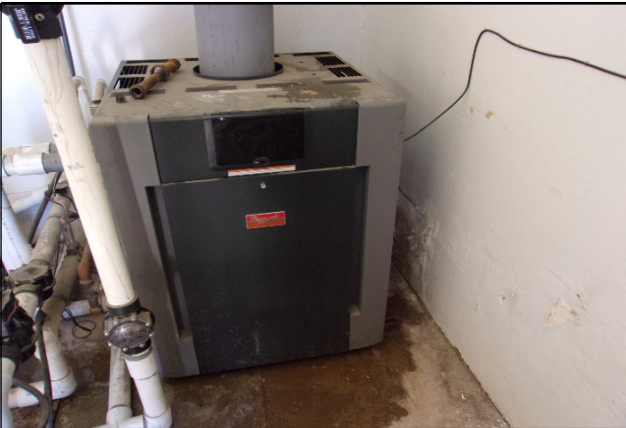
Comp # 1104 Pool Heater - Replace

No problems reported at time of site visit. This type of pool heater typically has a useful life of approximately 10 to 12 years. Remaining life based on current age and condition.

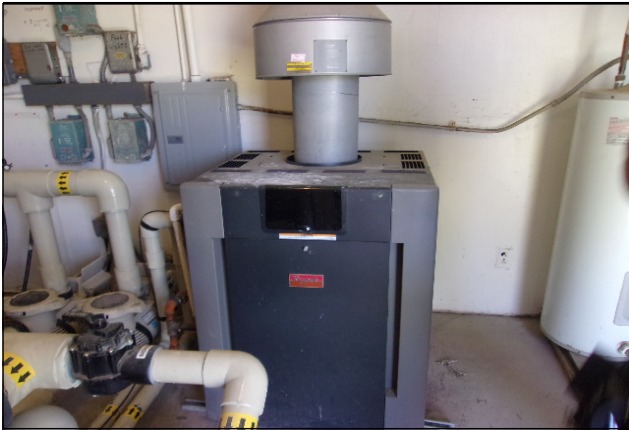
Pool heater is in good condition. No problems noted. This type of pool heater typically has a useful life of approximately 10 to 12 years. Remaining life based on current age and condition.

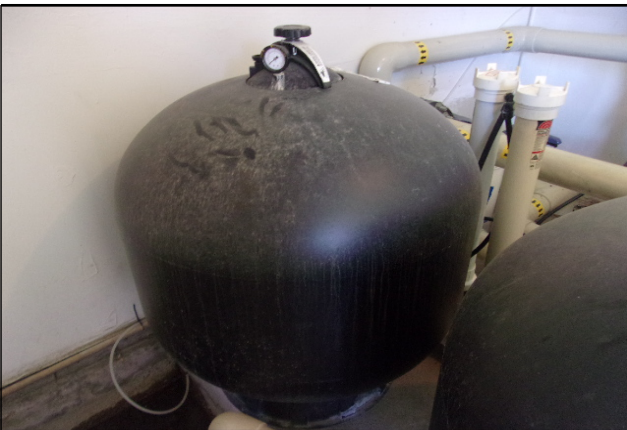
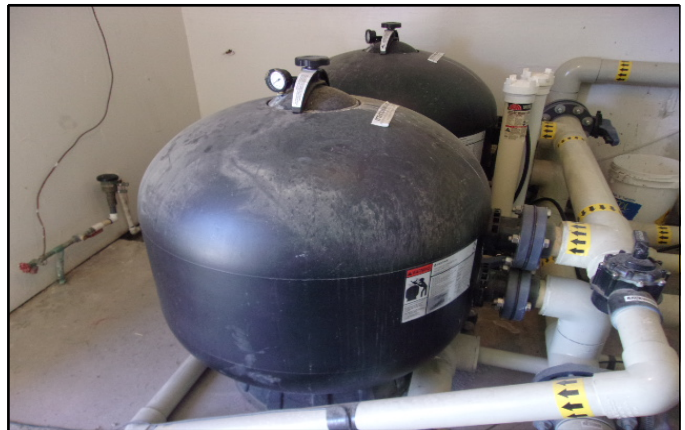
Comp # 1107 Pool Filter - Replace (One Nation Pool)

Pool filters are in good condition. No problems noted at the time of site visit. These type of pool filter have a life expectancy of approximately 12 years. Remaining life based on current age and condition.

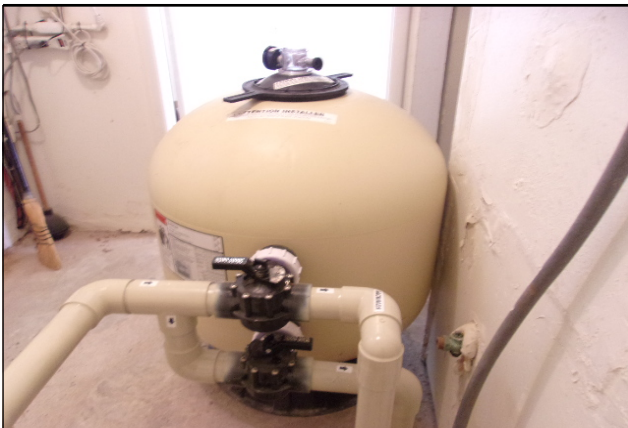
Comp # 1107 Pool Filter - Replace

Pool filter is in good condition. No problems noted at the time of site visit. This type of pool filter has a life expectancy of approximately 12 years. Remaining life based on current age and condition.

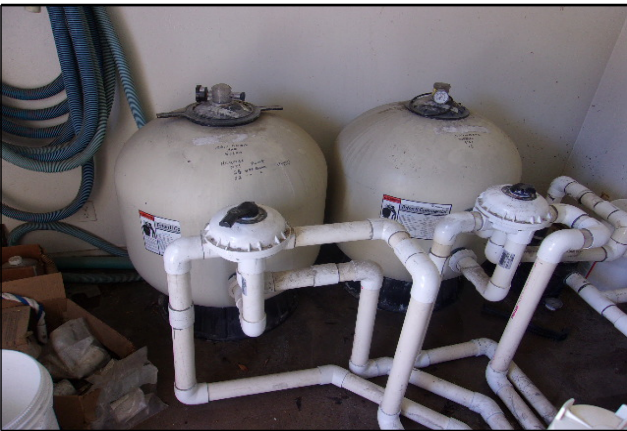
Comp # 1107 Pool Filter - Replace

Pool filters appear to be in good to fair condition, no problems noted at the time of site visit. These type of pool filters have life expectancy of approximately 10 to 12 years but can have an extended life with proper maintenance and care. Remaining life based on age and condition.

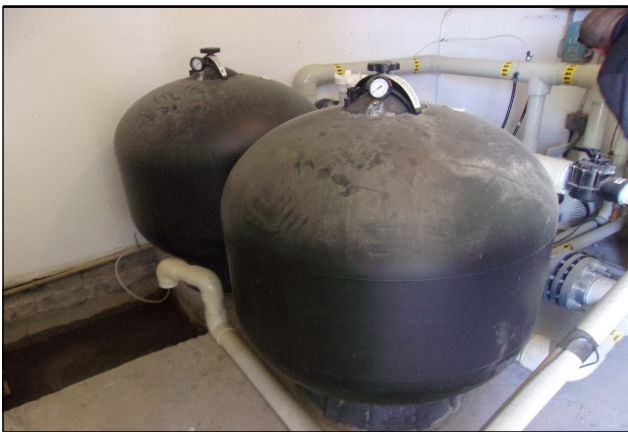
Comp # 1108 Pool Filter Sand - Replace (One Nation Pool)

Expect to replace pool filter sand approximately every 2 to 3 years.

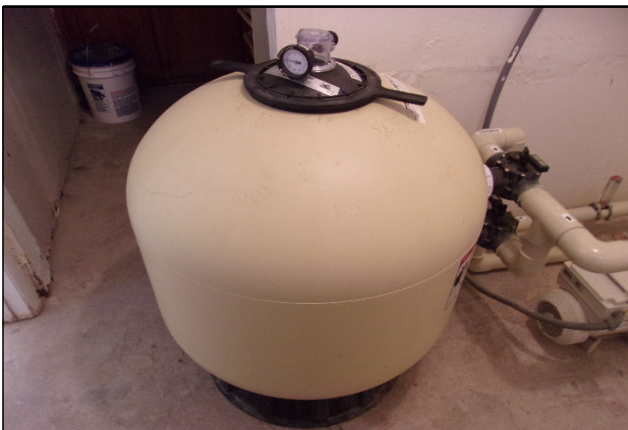
Comp # 1108 Pool Filter Sand - Replace

We are funding to replace filter sand approximately every 2 to 3 years. Remaining useful life based on current age.

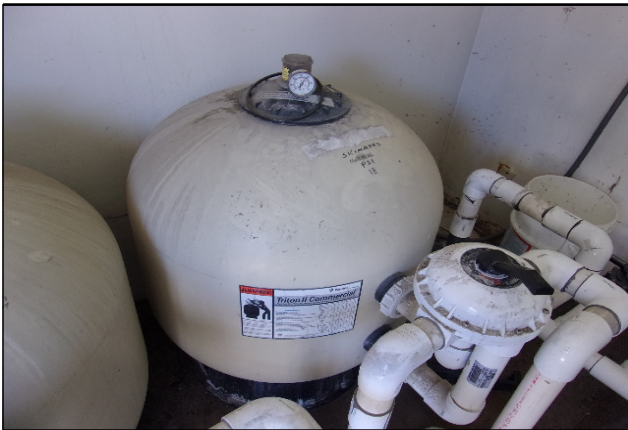
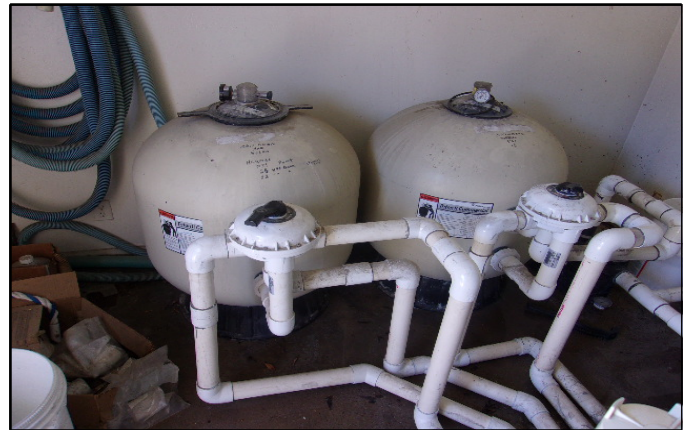
Comp # 1108 Pool Filter Sand - Replace

We are funding to replace filter sand approximately every 2 to 3 years. Remaining useful life based on current age.

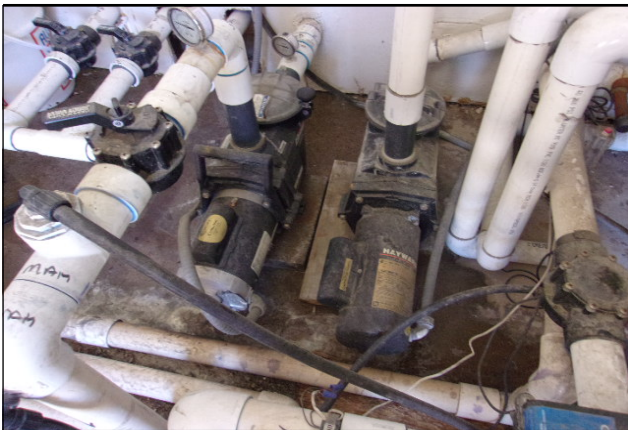
Comp # 1110 Pool Pumps - Replace (Operating)

No expectation to replace all pumps at one time. Due to the minimal cost to replace individual pumps we recommend repairing/replacing pumps as necessary as an operating expense. No reserve funding necessary.

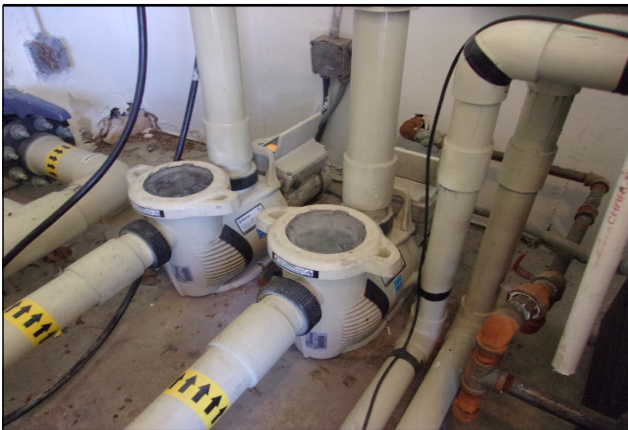
Comp # 1110 Pool Pumps - Replace (Operating)

No expectation to replace all pumps at one time. Due to the minimal cost to replace individual pumps we recommend repairing/replacing pumps as necessary as an operating expense. No reserve funding necessary.

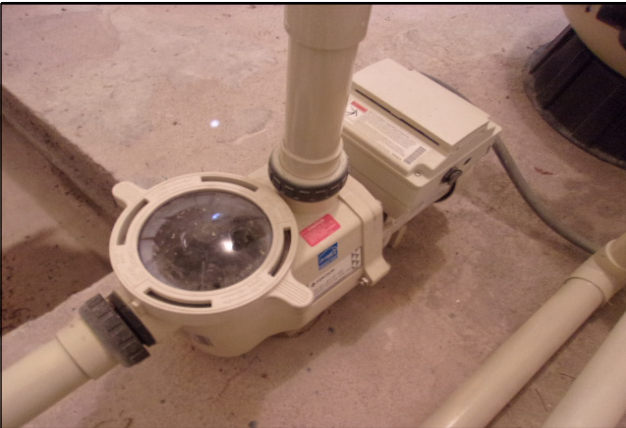
Comp # 1110 Pool Pumps - Replace (Operating)

Pump is in good condition. No problems noted at the time of our site visit. Expect a useful life of approximately 8 to 10 years from these pumps. Replace motors as necessary as an operating expense.

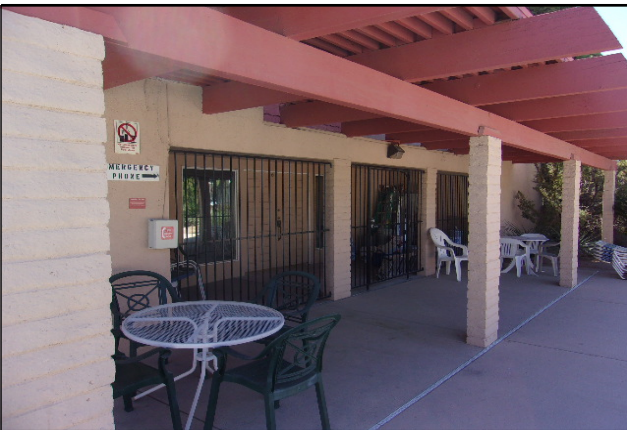
Comp # 1121 Pool Furniture - Replace

Pool furniture is in fair condition. No broken straps or significant sun damage noted at the time of inspection. Expect a useful life of approximately 5 years from this component. Remaining life based on current condition.

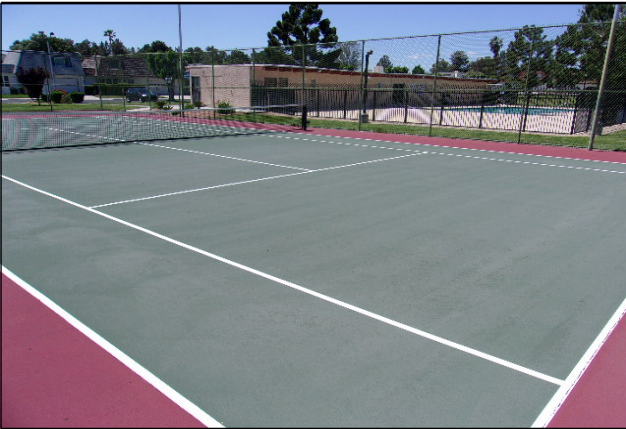
Comp # 1201 Courts - Resurface

Sports courts are generally in good condition. No significant cracking or surface loss noted at the time of inspection. Expect to resurface tennis court approximately every 8 years assuming normal use and wear. Remaining life based on current condition.

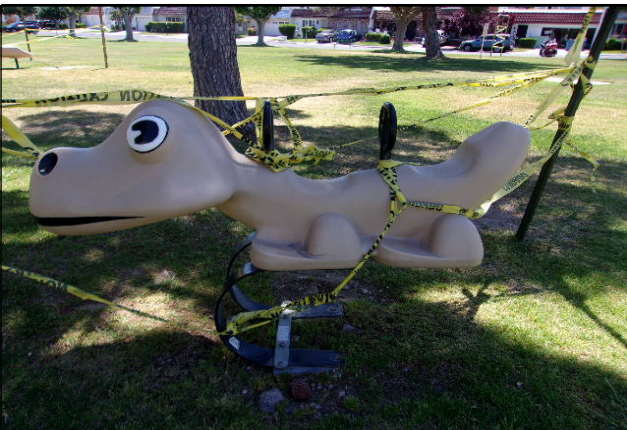
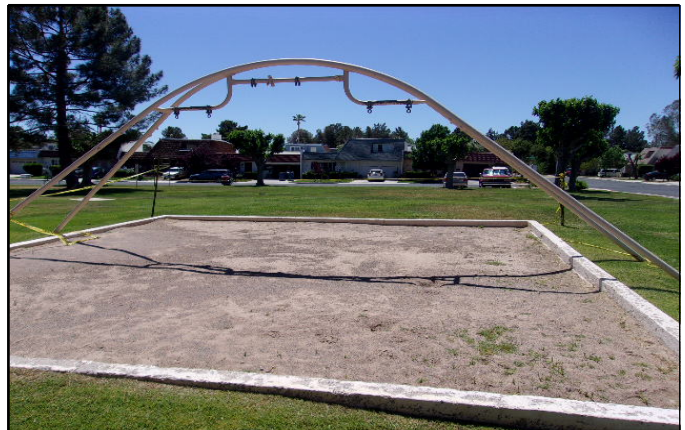
Comp # 1301 Play Equipment - Replace

Play equipment was in the process of being replaced at time of site visit. We recommend funding to replace this equipment approximately every 15 to 20 years.
