# Heritage Square South

## Level 1 Reserve Study

**Report Period - 1/1/2020 to 12/31/2020**

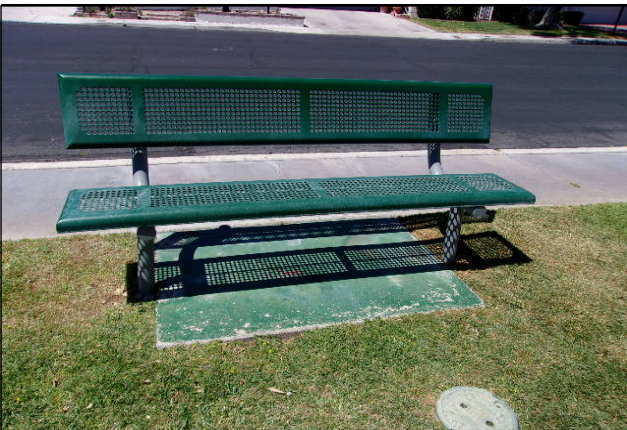
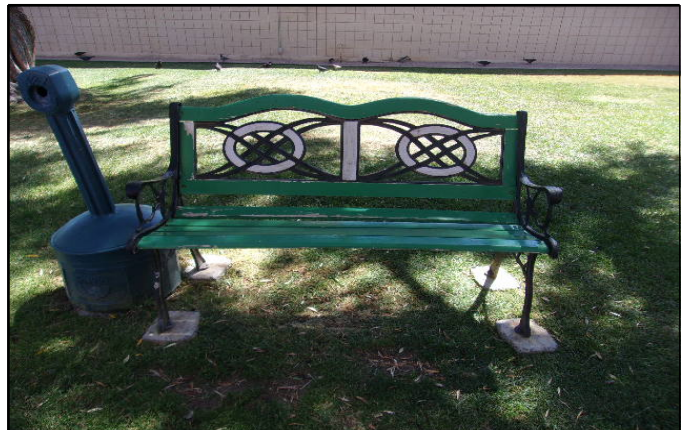
Comp # 1307 Park Furniture - Replace

Benches and pet waste stations are in good to fair condition and generally aging normally. Expect a useful life of approximately 10 years from this component. Remaining life based on current condition.

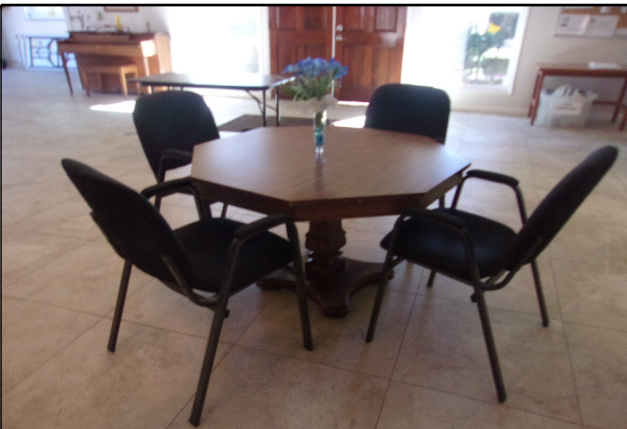
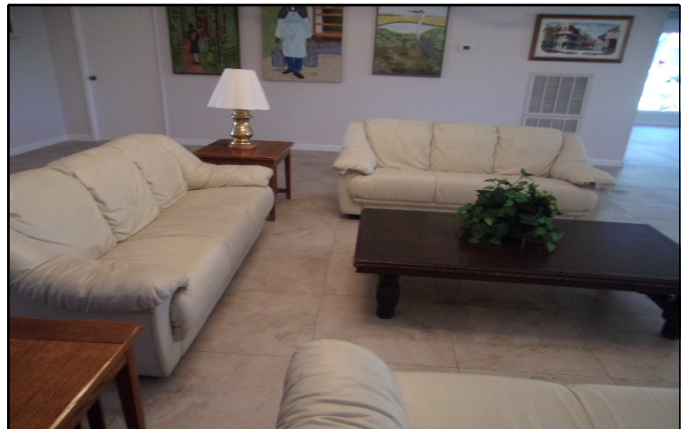
Comp # 1405 Clubhouse Furniture - Allowance

Furniture is generally in good to fair condition. No significant signs of wear or appearance concerns noted at the time of inspection. We recommend funding to make significant replacements to furniture approximately every 10 years to maintain appearance and keep up with decorative tastes.

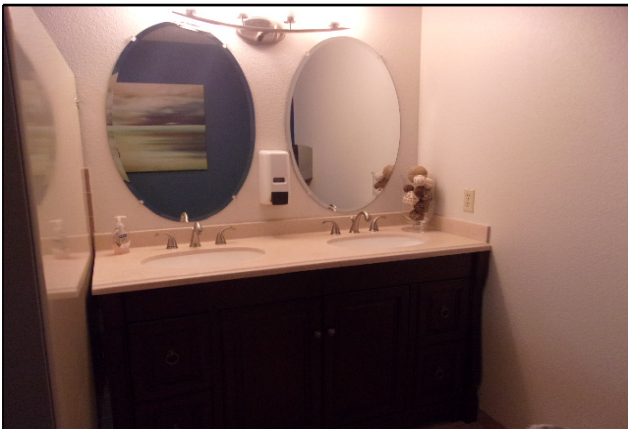
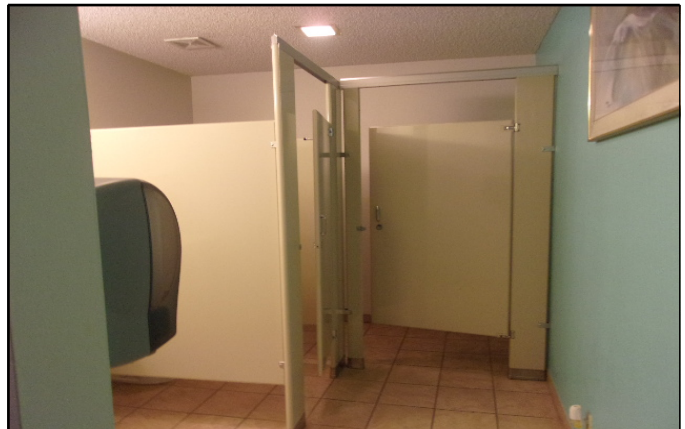
Comp # 1413 Restroom - Remodel

Restrooms are in good condition. No appearance concerns noted at the time of inspection. We recommend funding to generally remodel and refurbish these restrooms approximately every 18 years to maintain appearance and keep up with current decorative tastes.

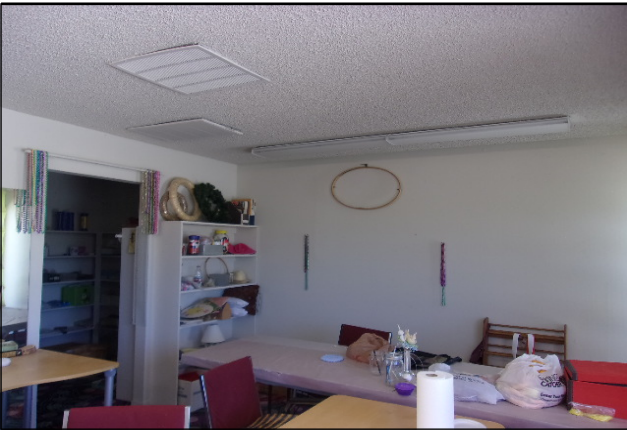
Comp # 1413 Pool Building - Remodel

Poolhouse interior is in fair to poor condition. Noted several rooms that are not being used and missing decor (flooring, paint, etc.). We have provided an allowance to remodel and refurbish this building's interior to place it back into full service. Note: this allowance may not be adequate if there are electrical/code issues that need to be corrected.

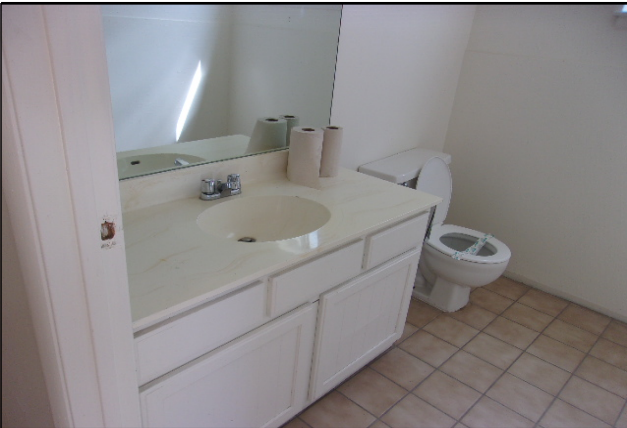
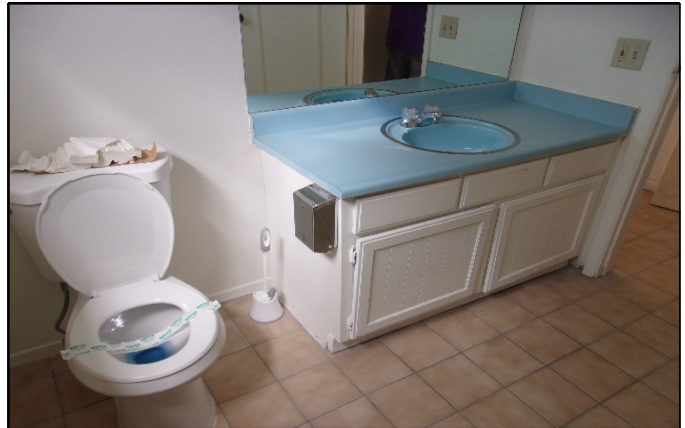
Comp # 1413 Restroom - Remodel

Restrooms are older but in fair condition. We recommend funding to generally remodel and refurbish these restrooms approximately every 16 years to maintain appearance and keep up with current decorative tastes.

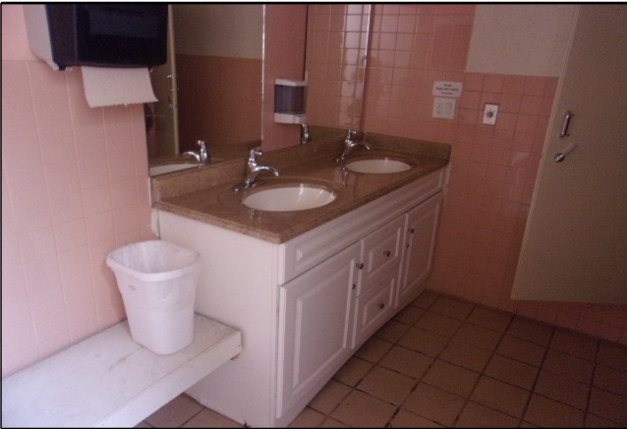
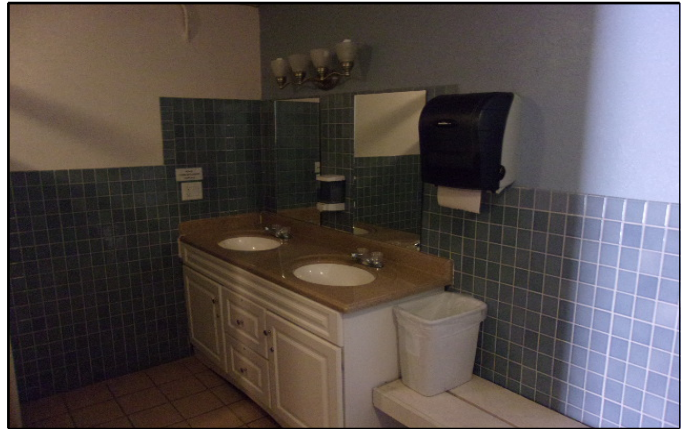
Comp # 1414 Locker Rooms - Remodel

Restrooms are in good to fair condition. No appearance concerns noted at the time of site visit. We recommend funding to generally remodel and refurbish these restrooms approximately every 15 to 20 years to maintain appearance and keep up with current decorative tastes.

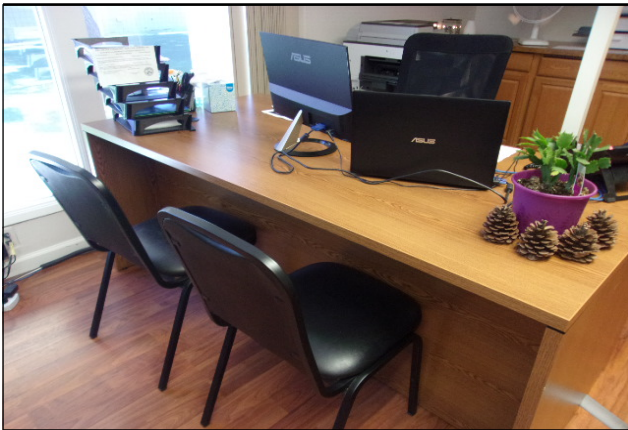
Comp # 1416 Office - Remodel

We recommend funding to remodel this office approximately every 15 years to ensure a functional workplace.

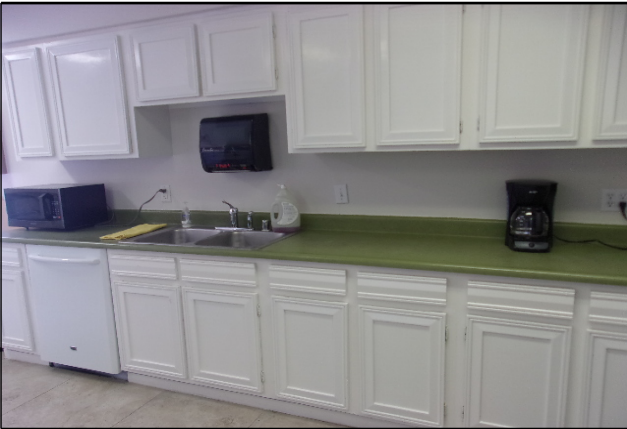
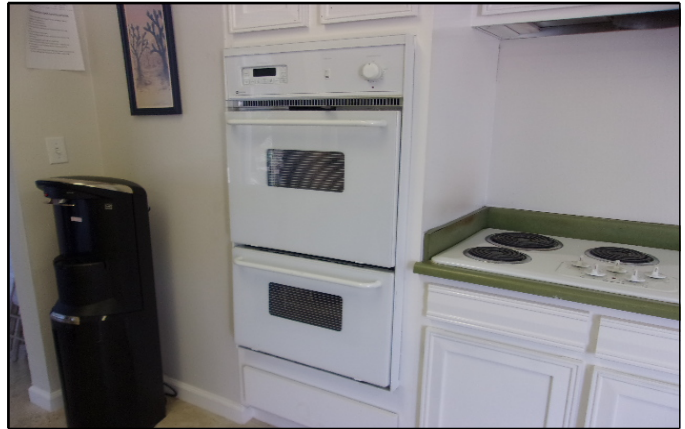
Comp # 1417 Kitchen - Remodel

Kitchen is generally in good condition. No appearance concerns observed. Expect to remodel kitchen approximately every 15 to 20 years to keep up with current current taste and ensure proper function of appliances. Remaining life based on current condition.

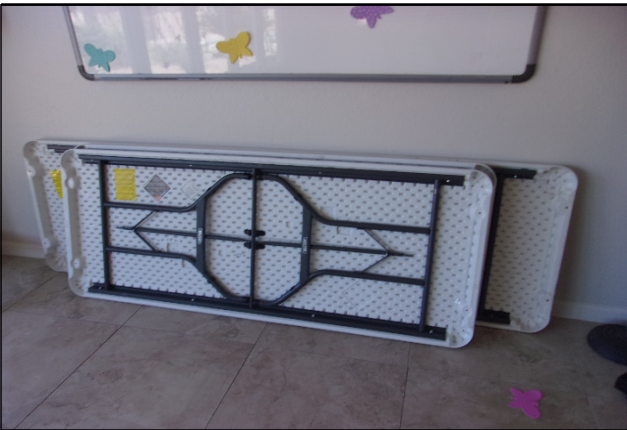
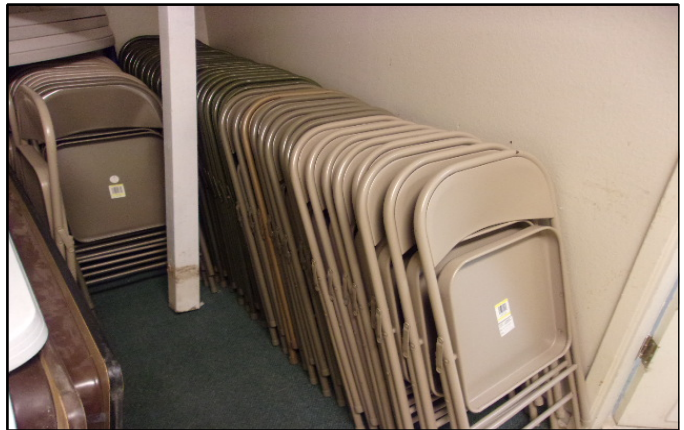
Comp # 1418 Banquet Equipment - Partial Replacement

Banquet equipment is in good condition. Expect a full useful life of approximately 8 to 10 years from this component.

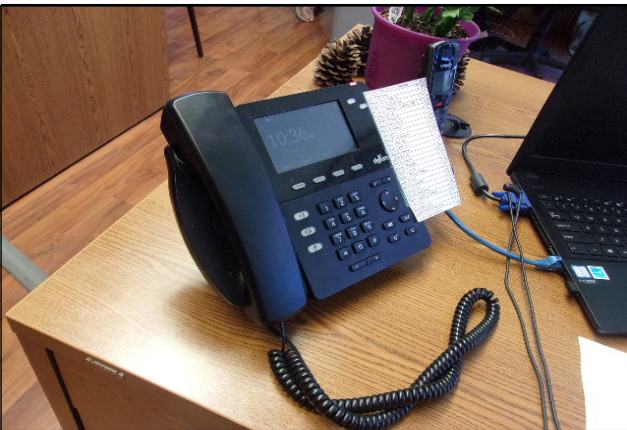
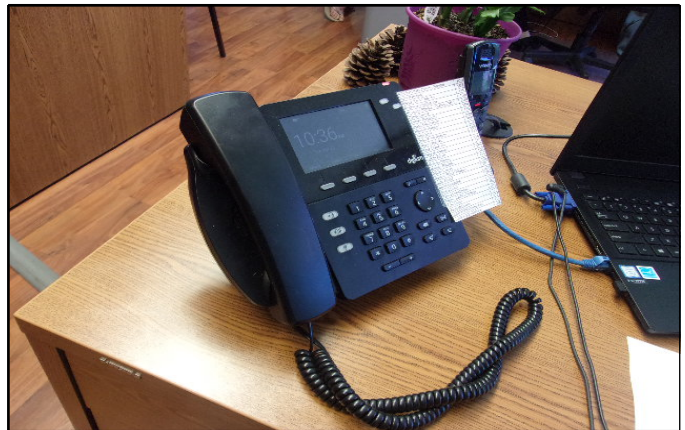
Comp # 1418 Office Equipment - Replace

We recommend funding for an allowance to replace this computers/computer equipment, phones, etc. approximately every 5 years to ensure proper function and to keep up with current technology.

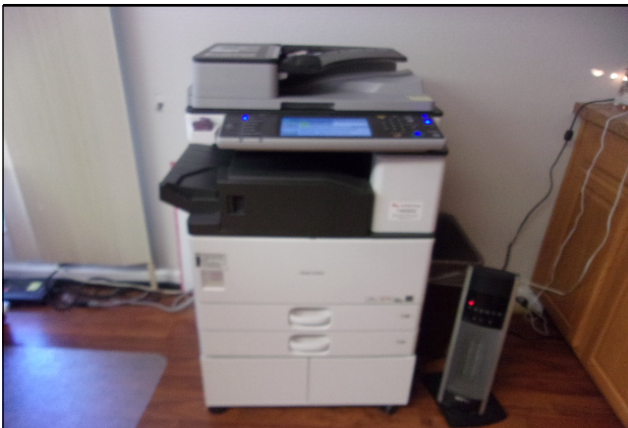
Comp # 1419 Copier - Replace

Copier was replaced in 2011. We recommend funding to replace this component approximately every 7 to 10 years. Remaining life based on current age.

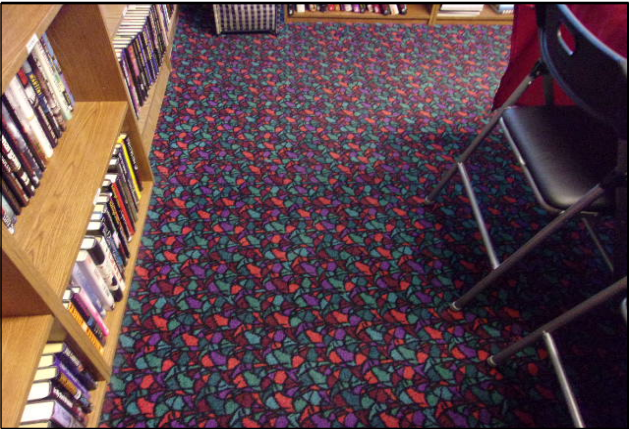
Comp # 1501 Carpeting - Replace

Carpet is in fair to poor condition. Some evidence of wear noted but no rips or curling seams observed at the time of site visit. Expect to replace this component approximately every 10 years assuming normal use and wear. Remaining life based on current age and condition.

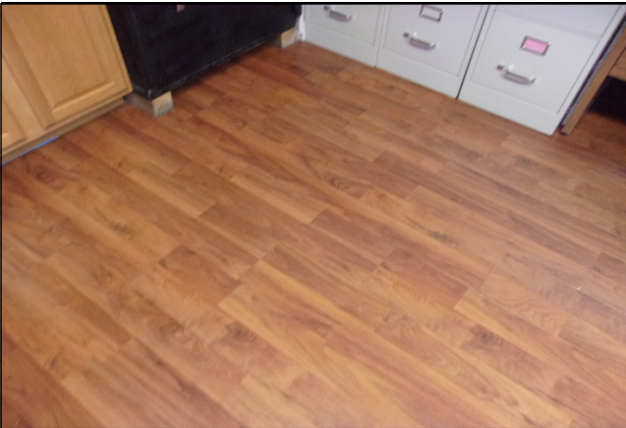
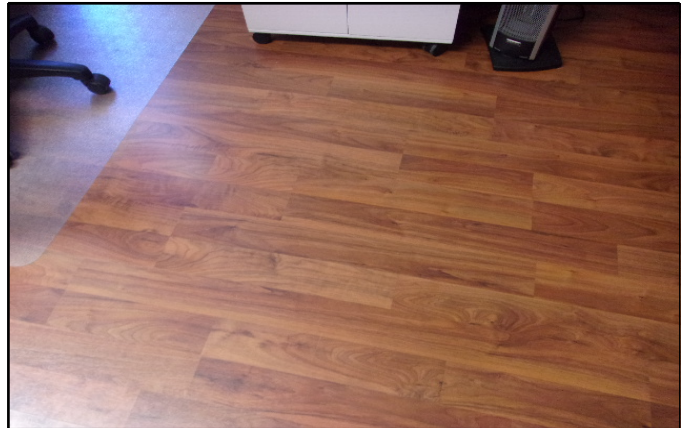
Comp # 1502 Laminate Flooring - Replace

No significant marking or curling seams noted at the time of Site visit. We recommend funding to replace this type of flooring approximately every 15 to 20 years depending on use and wear. Remaining life based on current condition.

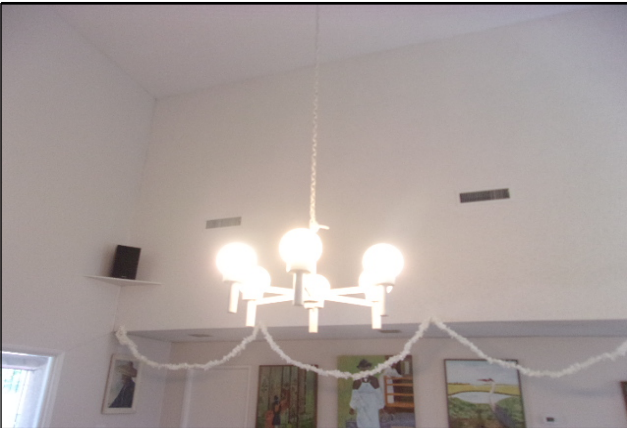
Comp # 1601 Interior Lights - Replace

Lights are generally in good condition. Expect to replace these lights approximately every 15 to 20 years to maintain appearance and to ensure proper function.

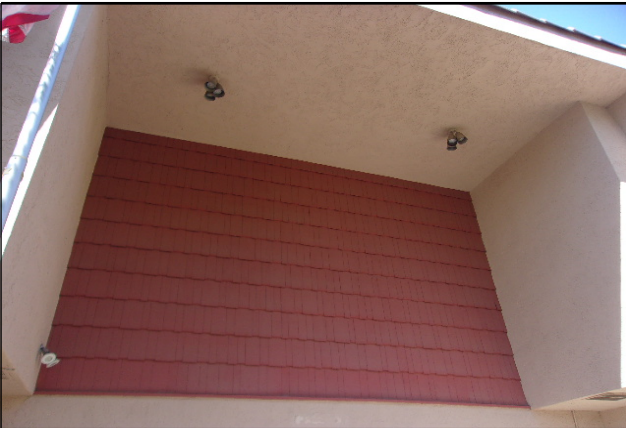
Comp # 1602 Exterior Wall Mount Lights - Replace (Operating)

Condition of lights varies. Due to the minimal cost associated with these lights we recommend replacing them as necessary as an operating expense. No reserve funding necessary.

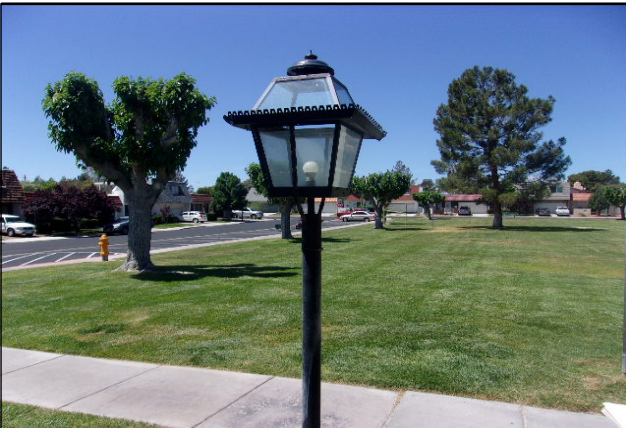
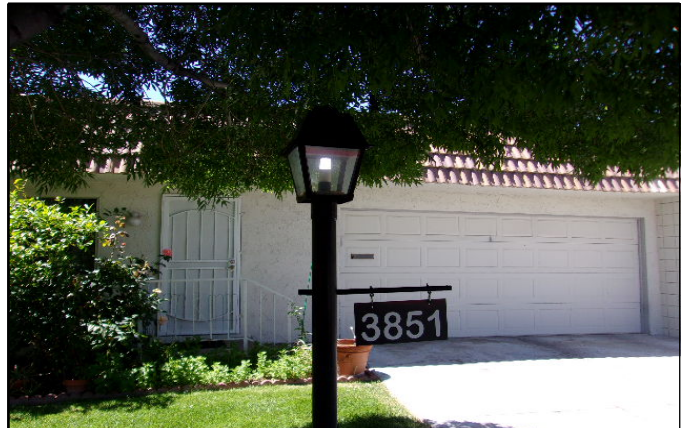
Comp # 1604 Pole Light Fixtures - Partial Replace

No structural problems noted with lights at the time of site visit. No expectation to replace all fixtures at one time under normal circumstances. We recommend funding for an allowance to make repairs/replacements approximately every 3 years. This allowance can be adjusted in future studies as the association develops a history or repairs/replacements.

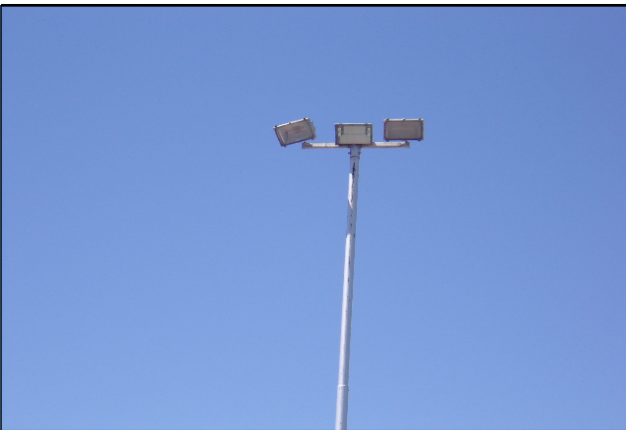
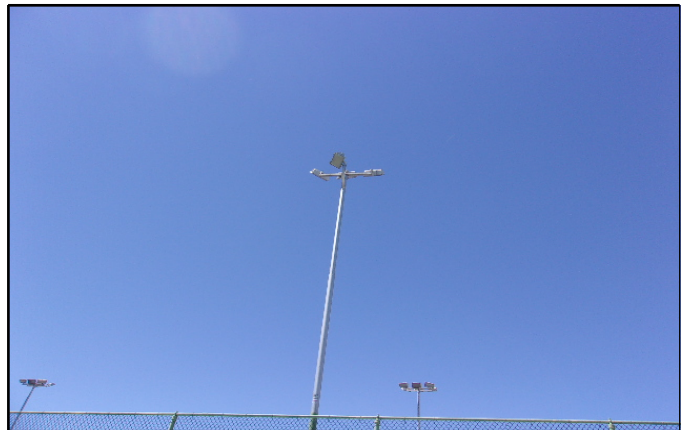
Comp # 1606 Tennis Court Light Fixtures - Replace

No problems noted or reported at the time of inspection. No expectation to replace light pole, reserve to replace light fixture only. Expect a useful life of approximately 25 years from this component.

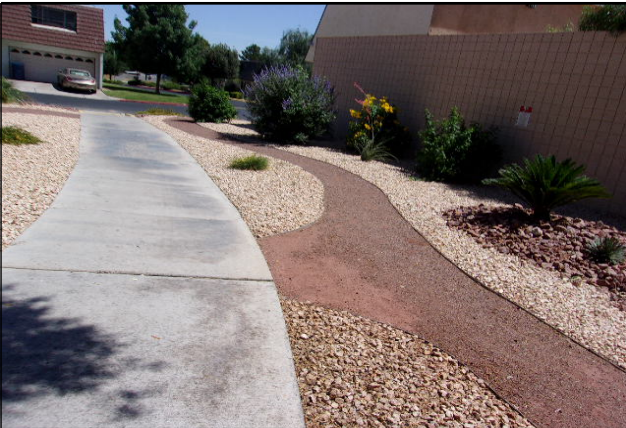
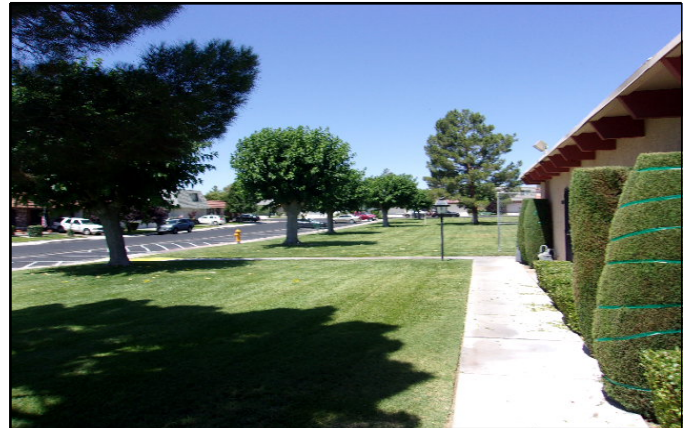
Comp # 1701 Irrigation System - Repair/Replace

Irrigation system is outdated and will need to be updated in the future. We recommend repairing the system when problems occur as an operating expense and doing a complete overhaul in the future.

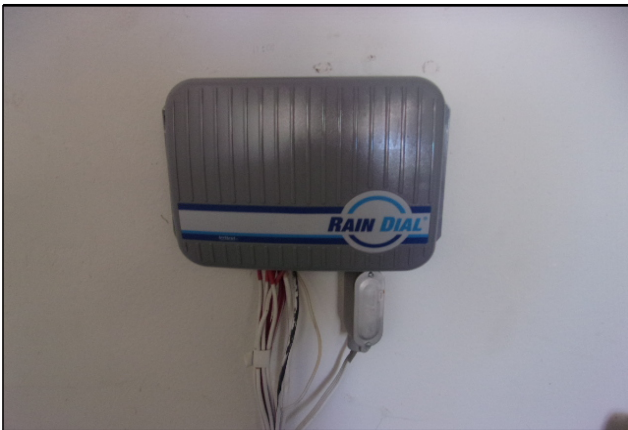
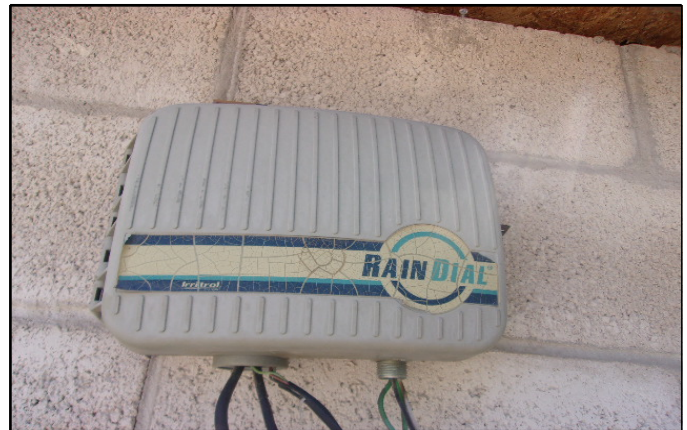
Comp # 1703 Irrigation Control System - Partial Replacement

No expectation to replace all clocks at one time under normal circumstances. We are funding to make replacements to the irrigation control system approximately every 5 years.

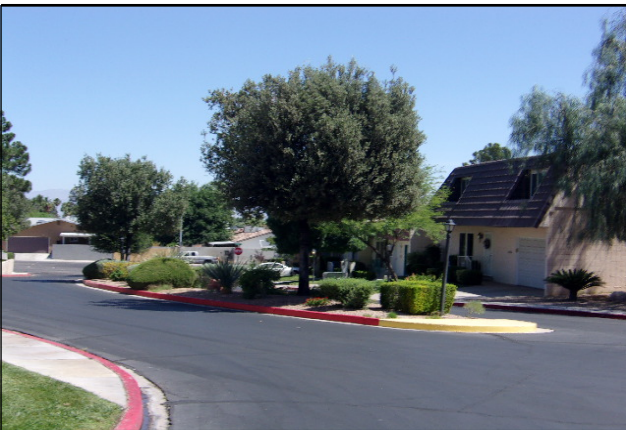
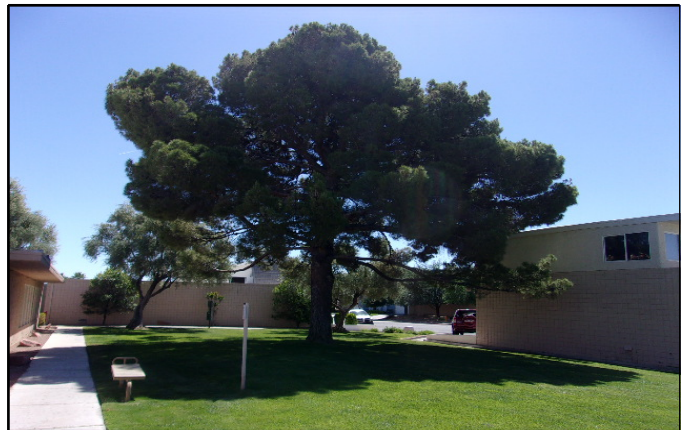
Comp # 1802 Tree Trimming / Removal - Perform

We recommend funding to perform tree maintenance including tree trimming and local replacements approximately every 3 years.

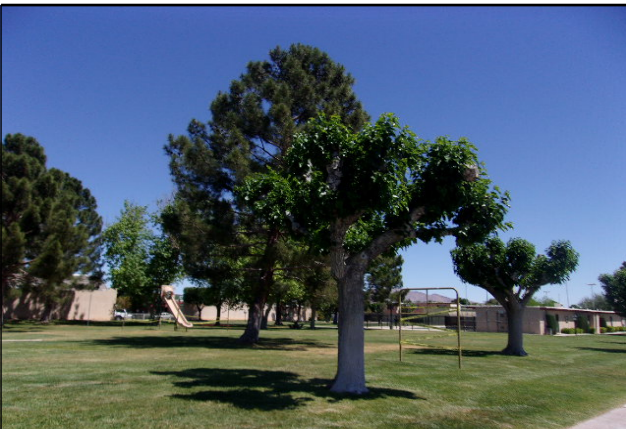
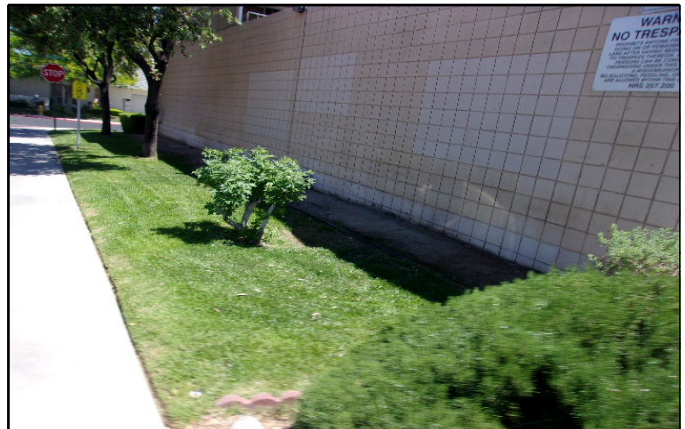
Comp # 1812 Landscaping - Renovate

No expectation to completely replace the landscaping. We recommend funding for an allowance to generally refurbish the landscaping, make local tree replacements, and make upgrades to the irrigation system and landscape lighting approximately every 10 years. Replace irrigation clocks, valves, etc. as necessary as an operating expense.

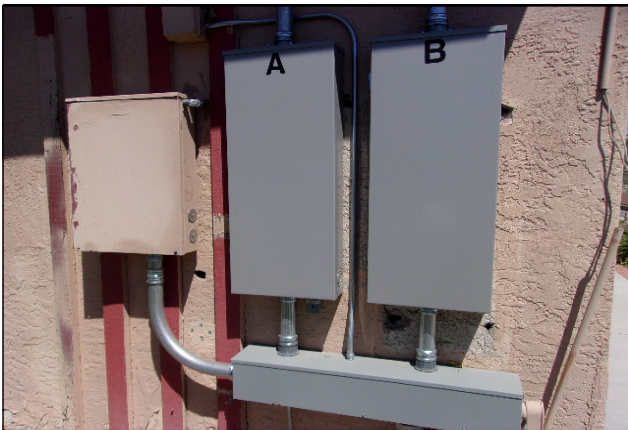
The client reported that the circuit breaker boxes need to be replaced in the near future. Although the electrical system is designed to last the life of the community we have funded for a similar project approximately every 30 to 35 years.

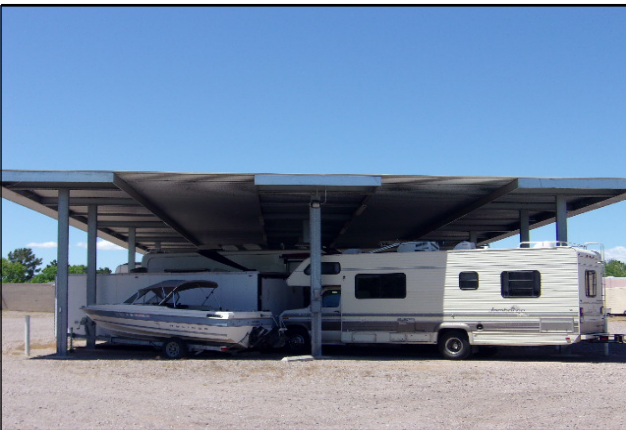
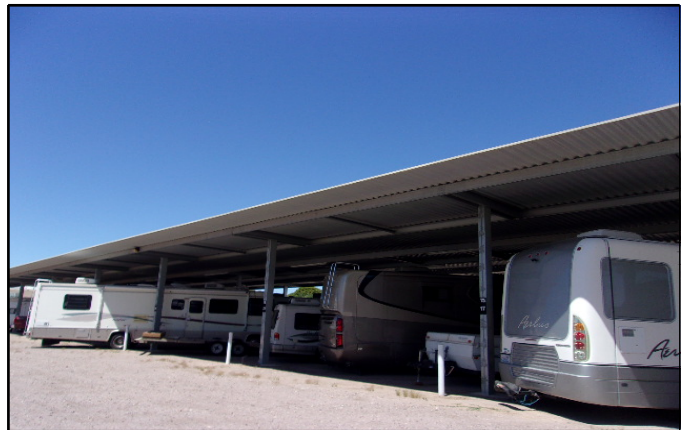
Comp # 2305 R.V. Shade Structure - Repair

No expectation to completely replace this structure under normal circumstances. We recommend funding for an allowance to generally repair and refurbish the structure approximately every 10 years.

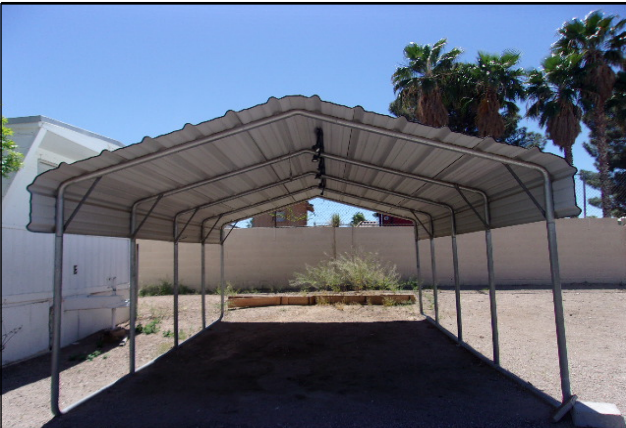
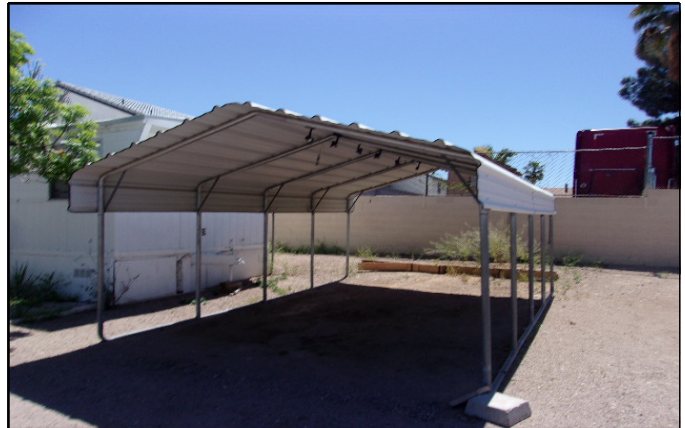
Comp # 2305 Parking Shade Structure - Repair

Although this structure may reach an extended life we recommend funding to replace this component approximately every 20 years. Remaining life is based on current condition.
